GE 90 Inlet Cowl

001114

314W1400-9

REPAIRED

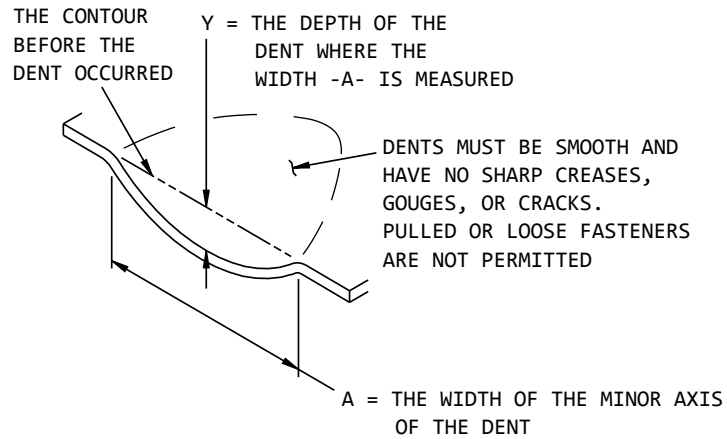
IT IS NOT NECESSARY TO REPAIR THE DENT IF:

- DENTS ARE SMOOTH AND HAVE NO GOUGES, CRACKS, OR SHARP CREASES
- $A/Y$  IS MORE THAN 8 AT ALL LOCATIONS ALONG THE DENT
- $Y$  IS 0.125 INCH (3.2 mm) OR LESS
- THE MAJOR AXIS OF THE DENT IS 4.00 INCHES (102 mm) OR LESS

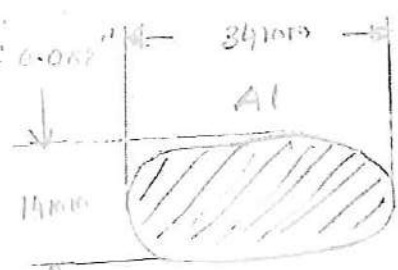
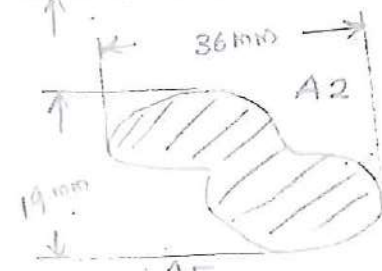
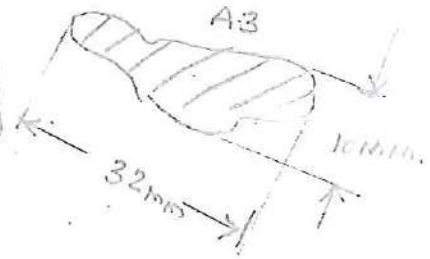
10 10 11  
0' CLOCK POSITION N

L	W	D
A1	34	14	0.003"
A2	36	19	0.002"
A3	32	10	0.001"
A4	14	9	0.001"
A5	13	10	0.001"
A6	11	10	0.001"
A7	17	9	0.001"

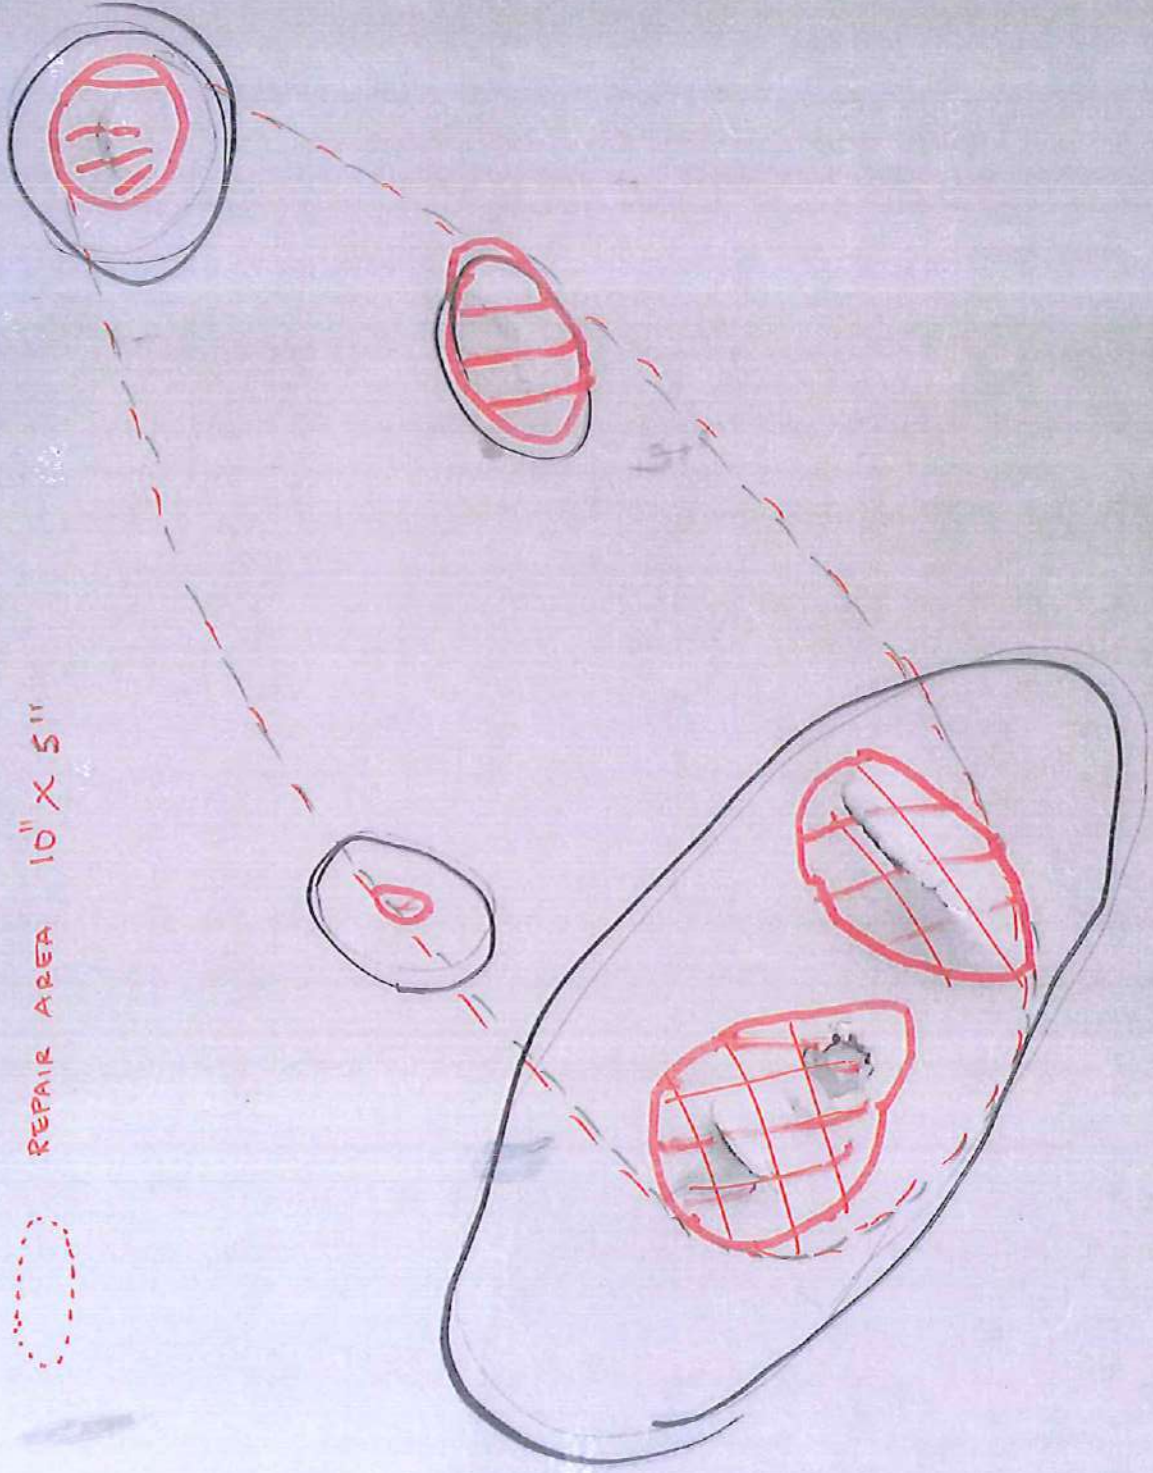
(B)

DISBONDED AREA

REPAIR AREA 10" X 5"

VISIT # 791349

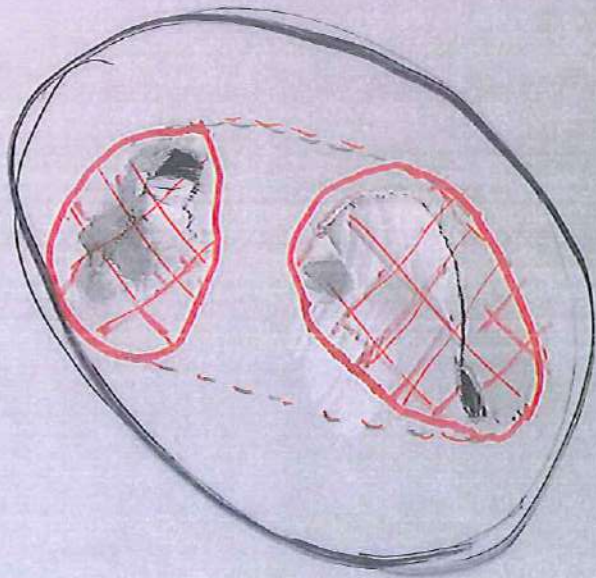
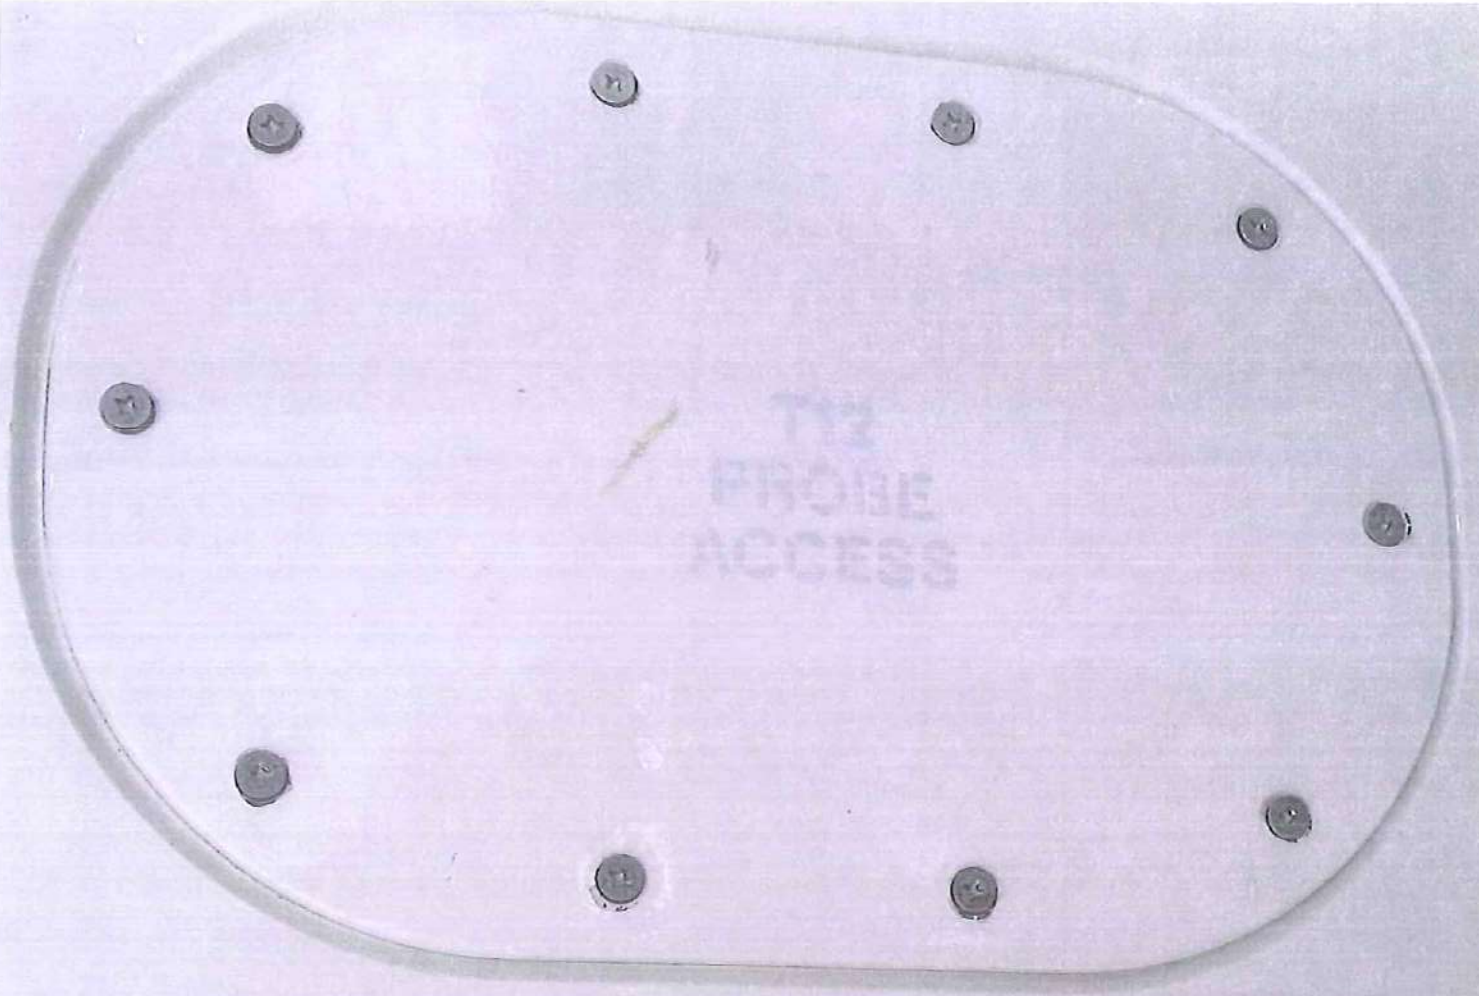
(C)

REPAIR AREA 6" X 3"

VISIT # 791349

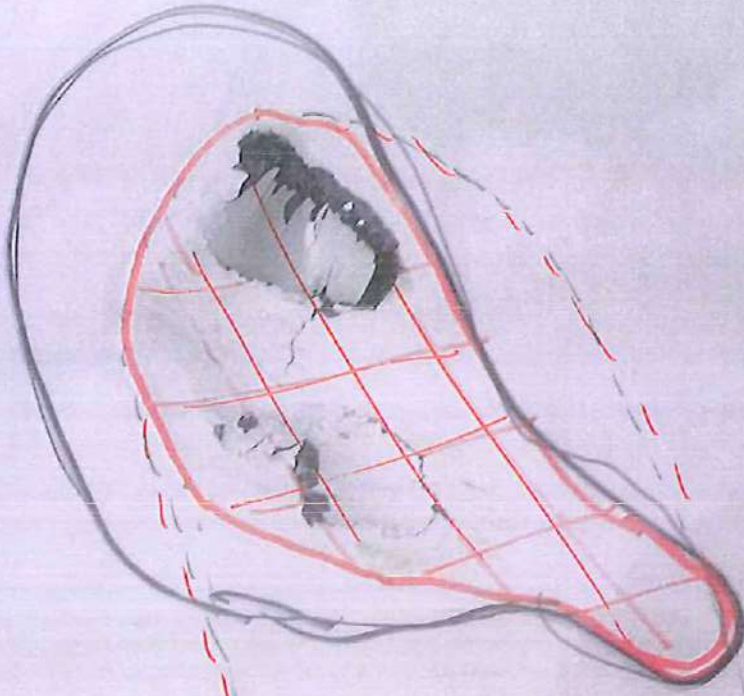
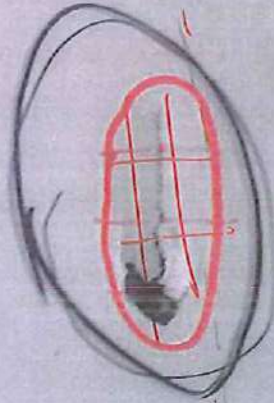
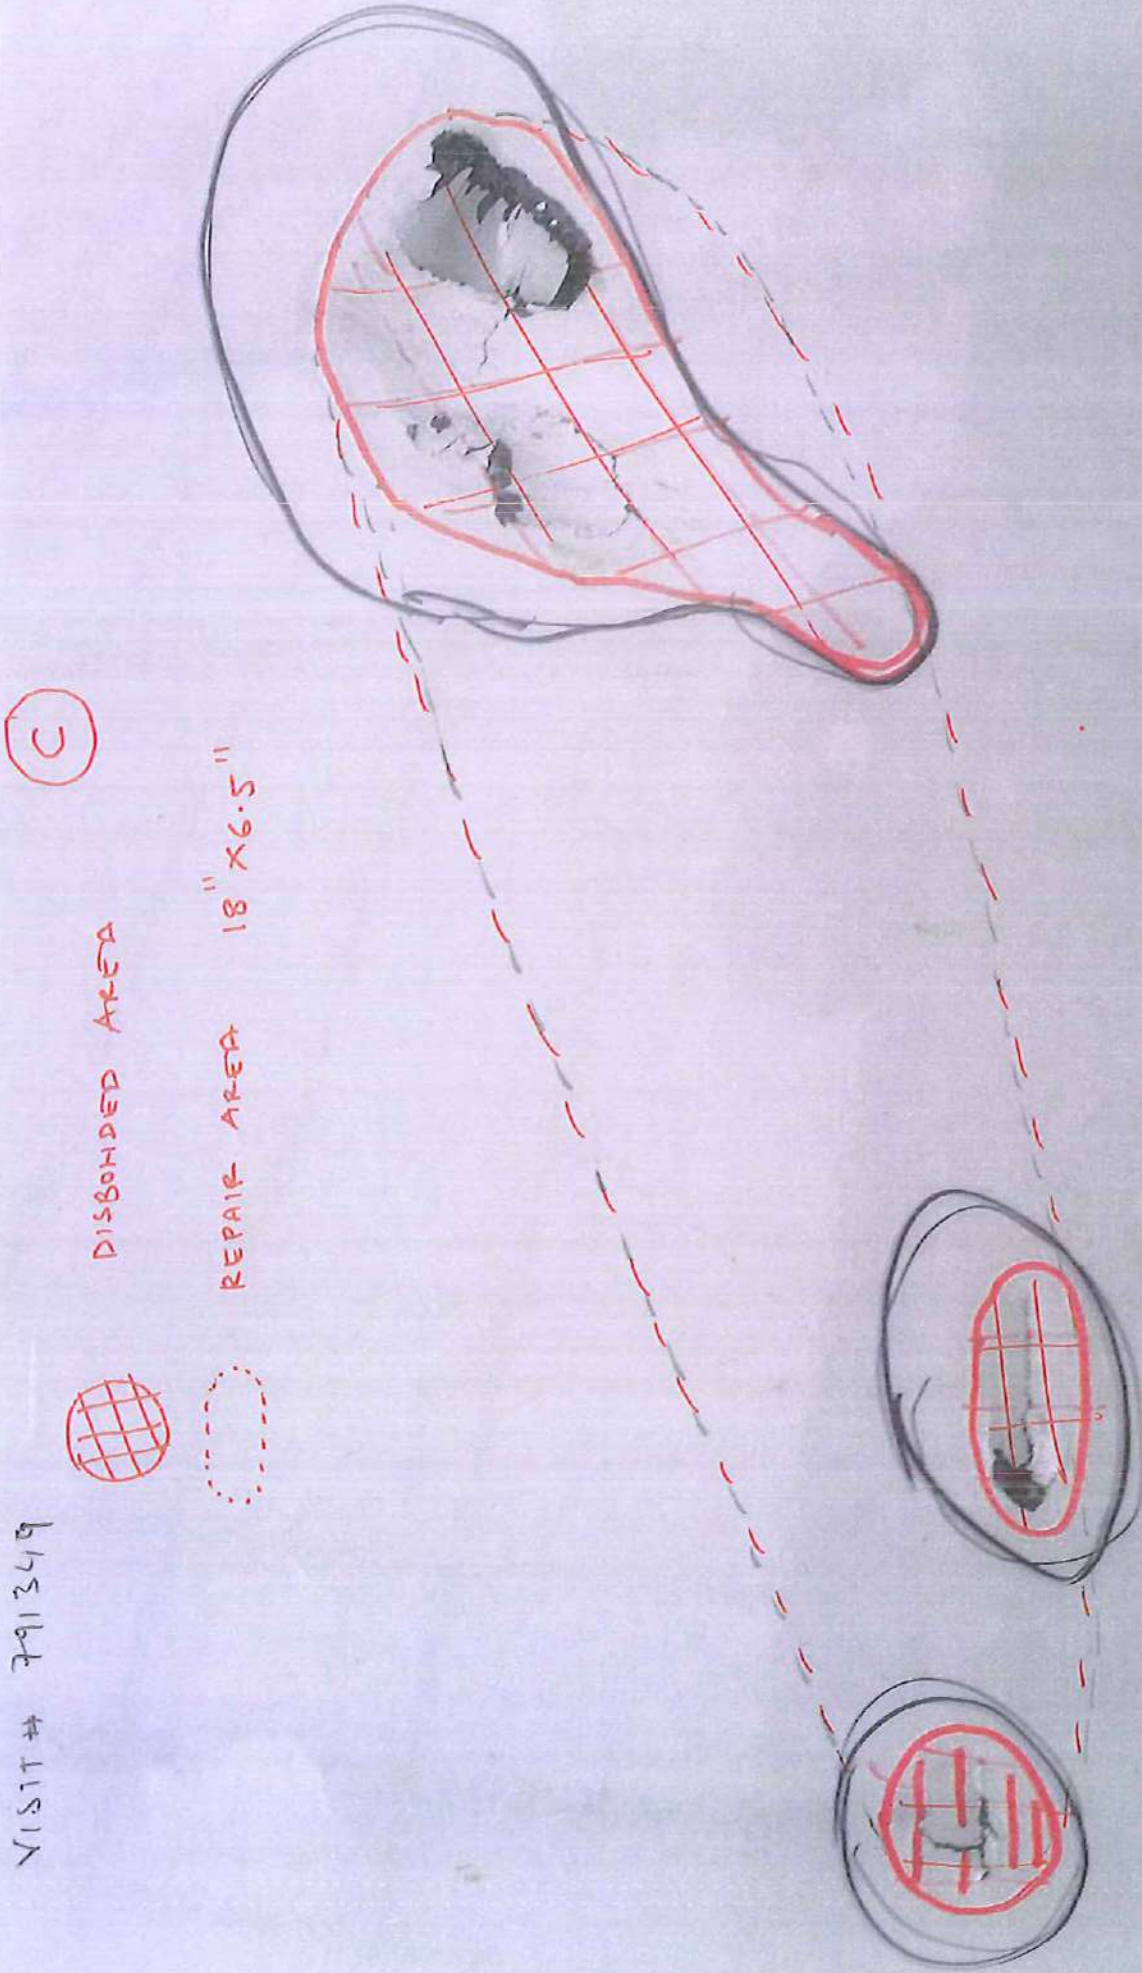
(D)

DISBONDED AREA

REPAIR AREA 18" X 6.5"

VISIT # 791349

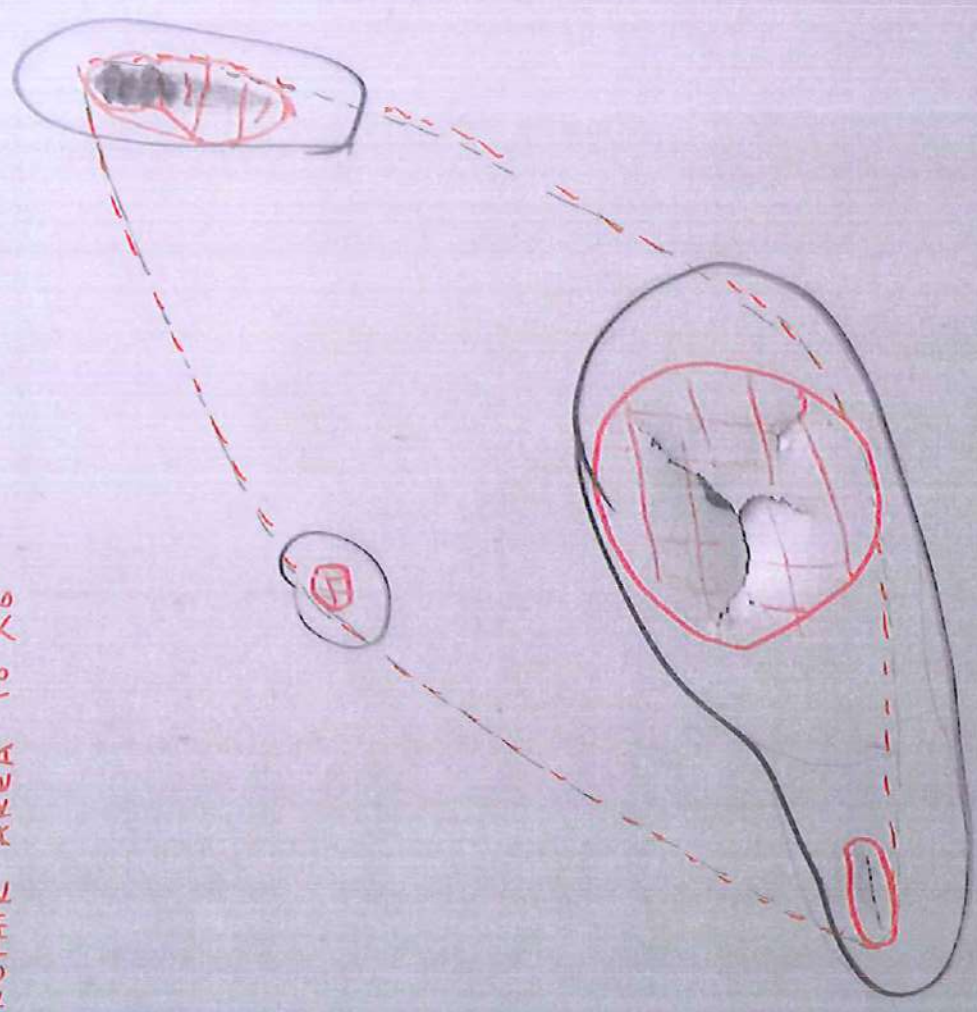
DISBORDER AREA

REPAIR AREA 18" X 6"
