Model Radome

**Serial** 000309

Part number 284T0052-41

Condition REPAIRED

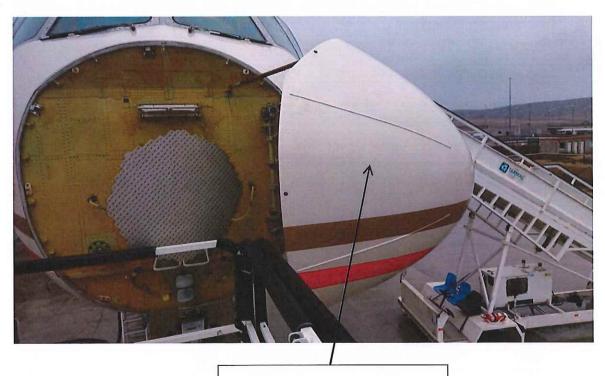
Inside part of the radome

## Results: **DISBONDING FOUND**
