GE90 Inlet Cowl

000865

314W1400-9

REPAIRED

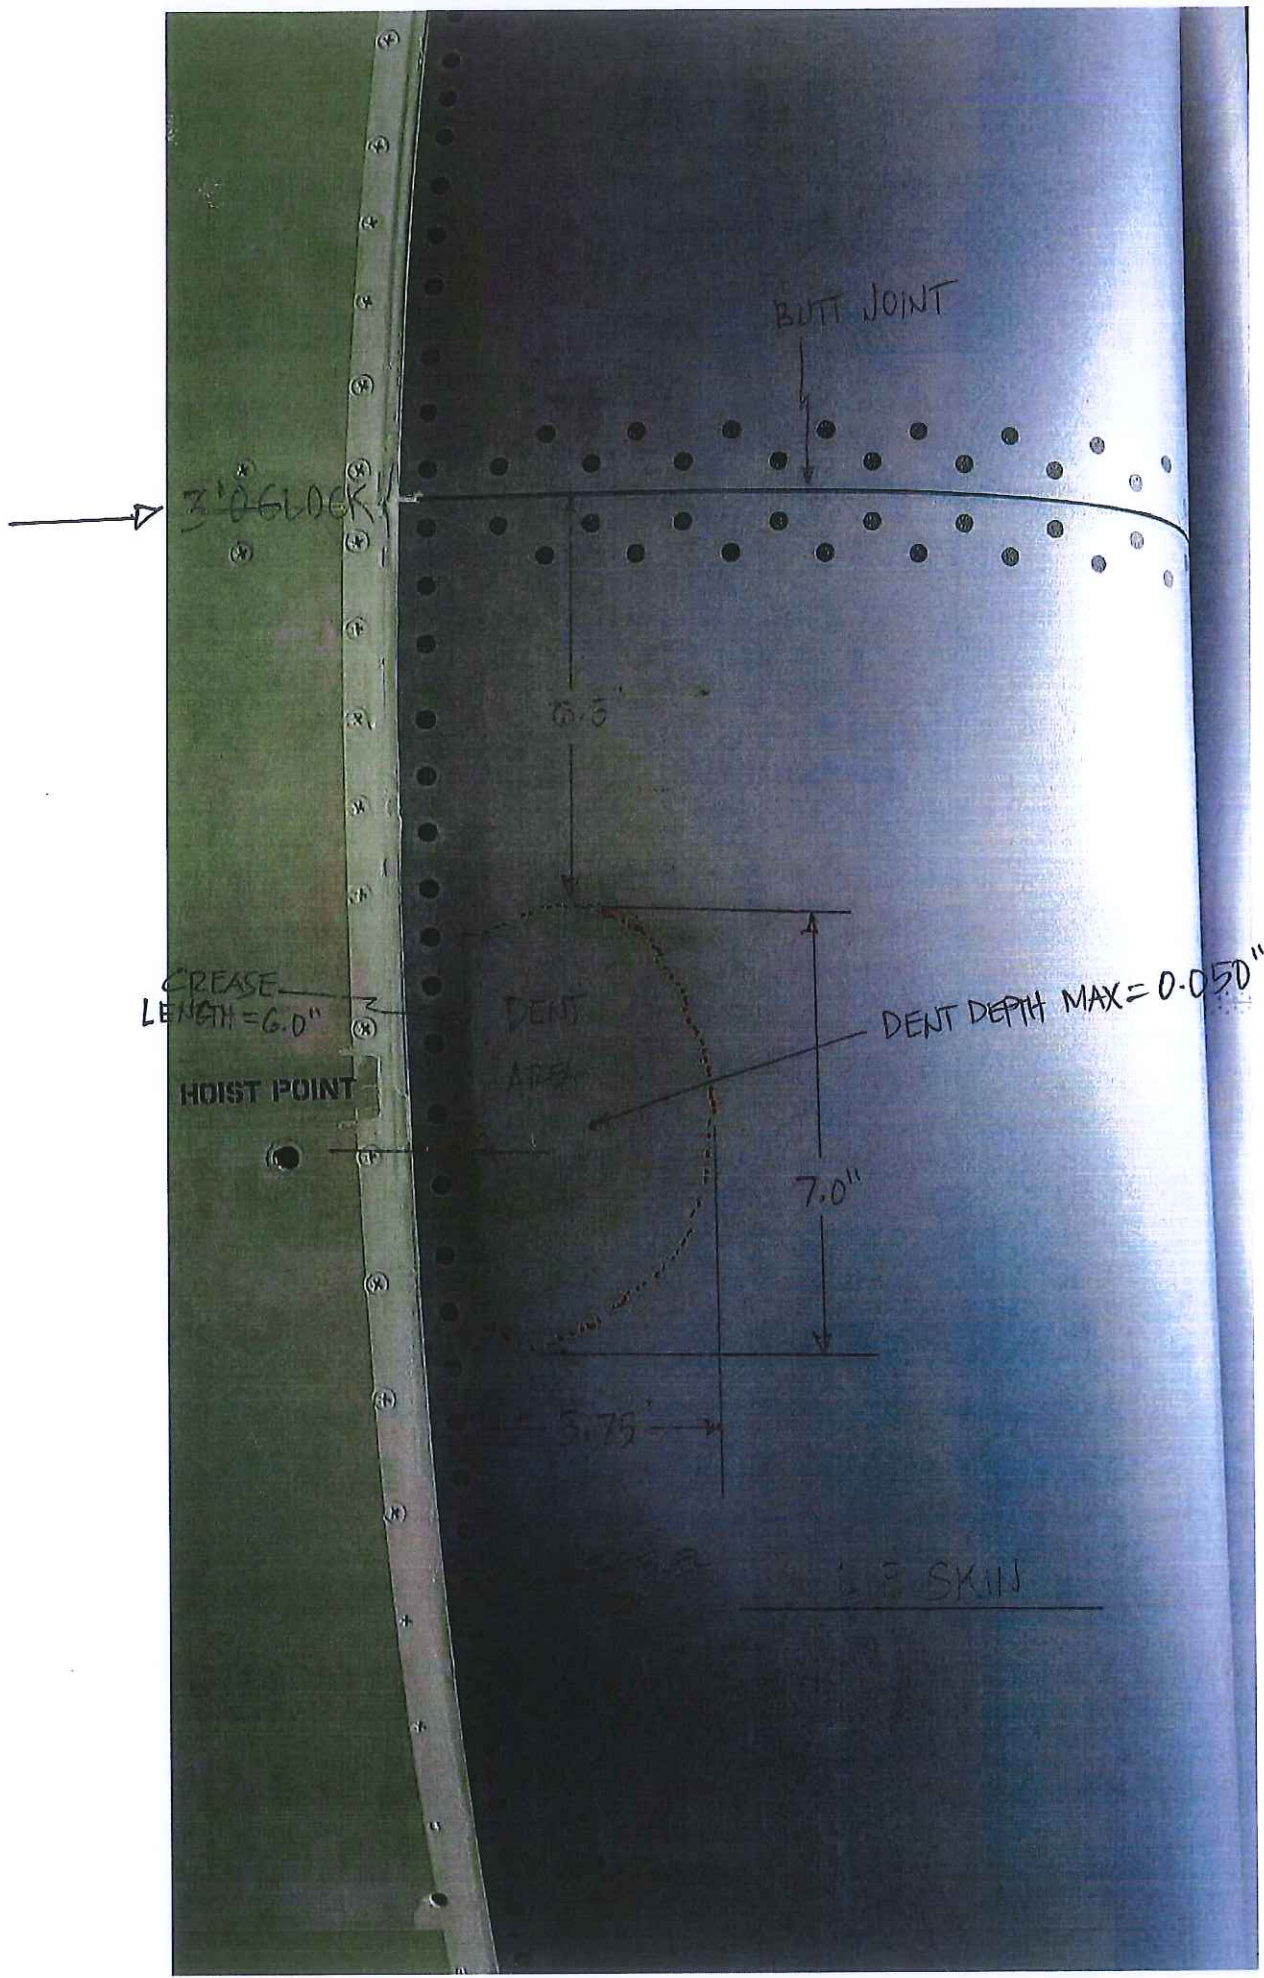
The dent with crease mark on the inlet cowl lipskin 6.5" below 3 O'clock Butt joint was dressed back to original contour have been approved as per Boeing RDR No. GMO-ETI-16-0024-10B dated 23 March 2016 provided following conditions are met:- Accomplish a FPI or HFEC inspection on the outside of the reworked area every 2A-Check or 4000 FH (whichever comes first) until next C-check equivalent or 1125 days or 18000 FH (whichever comes later) to ensure no cracks.

DETAILS OF TECHNICAL REQUEST: LH INLET COWL LIP SKIN FOUND WITH DENT WITH CREASE 6.5" BELOW BUTT JOINT AT 3 O'CLOCK POSITION AND 0.625" FROM FWD BULKHEAD/FRAME FASTENER ROW. IN REFERENCE TO SRM 54-13-01-1A-1 FIG. 103 DETAIL E, THE DENT WITH SHARP CREASE IS NOT ALLOWED. NO APPLICABLE REPAIR FOUND IN SRM 54-13-01-2R-1.

BUTT JOINT

3'06 LOCK

After the first inspections during every 2A-Check until next C-check if no cracks are present, perform FPI or HFEC inspection on the outside of the reworked area at the subsequent C-Check equivalent or 1125 days or 18000 FH (whichever comes first). If no cracks are found the repair structurally acceptable as permanent.
