## APU Service Record

<b>APU Type</b> APS5000A	<b>APU P/N</b> 7002907H05	<b>APU S/N</b> HSC-E1525347PL
TSN : 1137	TSO: UNK	TSR : 1137
		CSN : 1659
		CSO: UNK
		CSR : 1659

# Shop Findings Report

W0021262

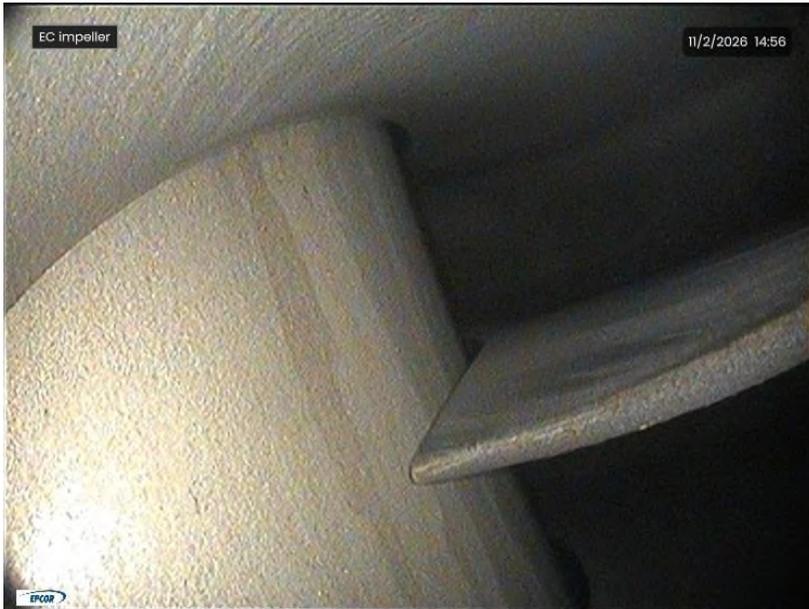
Engine\_Compressor\_EC\_impeller\_001.jpg

Module	Engine Compressor
Component	Compressor Impeller
Findings	No obvious damage
Comments

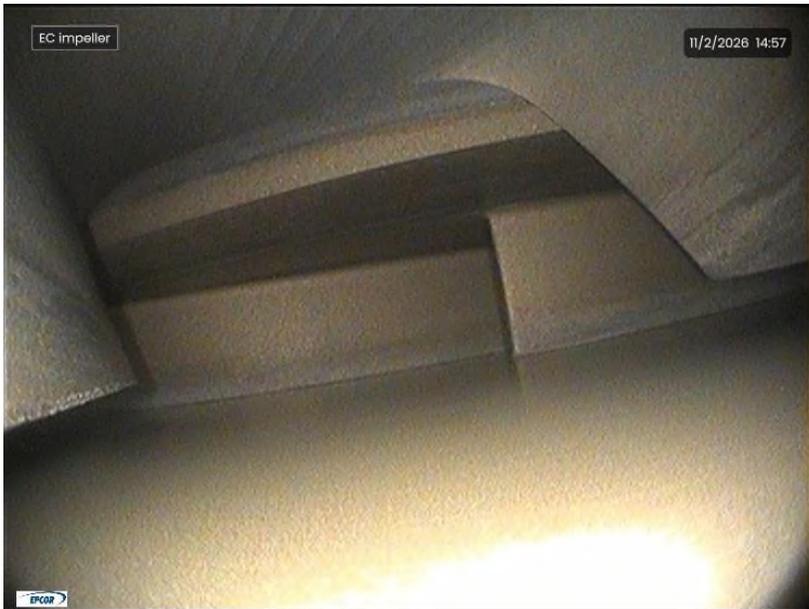
Engine\_Compressor\_EC\_impeller\_002.jpg

Module	Engine Compressor
Component	Compressor Impeller
Findings	No obvious damage
Comments

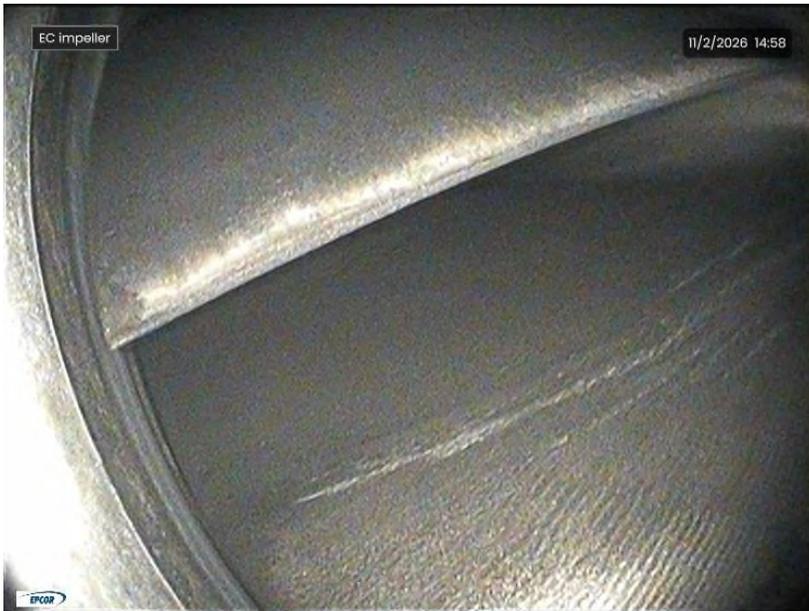
Engine\_Compressor\_EC\_impeller\_004.jpg

Module	Engine Compressor
Component	Compressor Impeller
Findings	No obvious damage
Comments

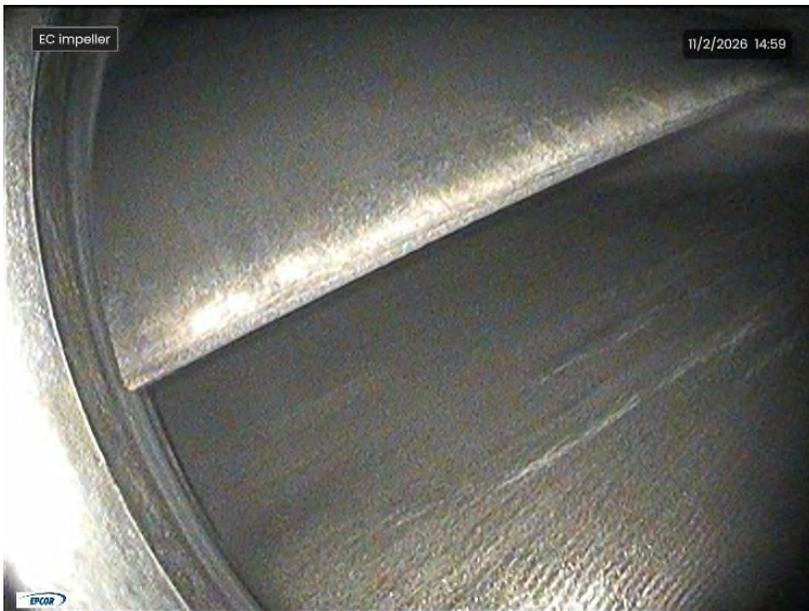
Engine\_Compressor\_EC\_impeller\_005.jpg

Module	Engine Compressor
Component	Compressor Impeller
Findings	No obvious damage
Comments

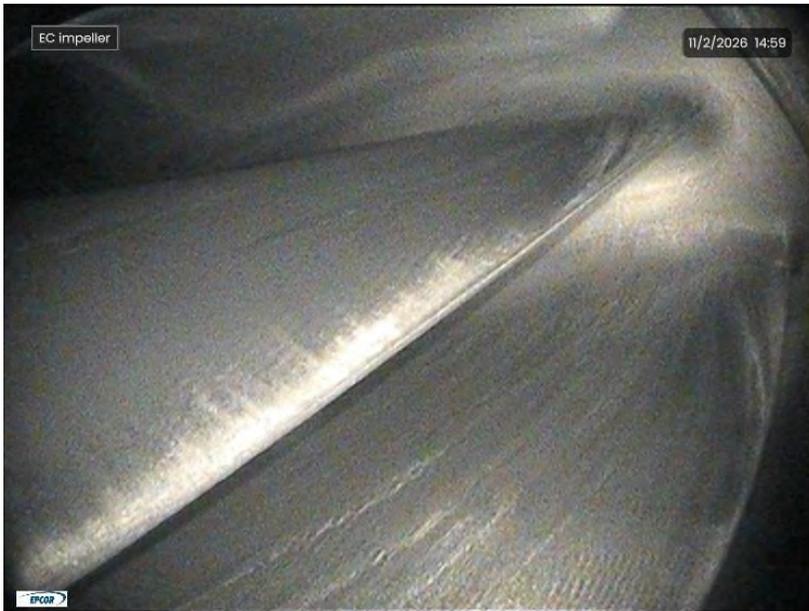
Engine\_Compressor\_EC\_impeller\_006.jpg

Module	Engine Compressor
Component	Compressor Impeller
Findings	No obvious damage
Comments

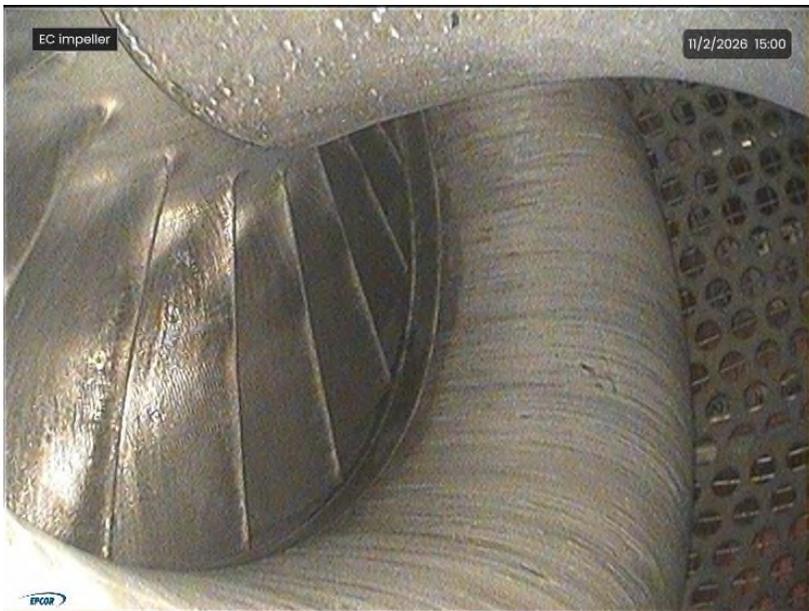
Engine\_Compressor\_EC\_impeller\_007.jpg

Module	Engine Compressor
Component	Compressor Impeller
Findings	No obvious damage
Comments

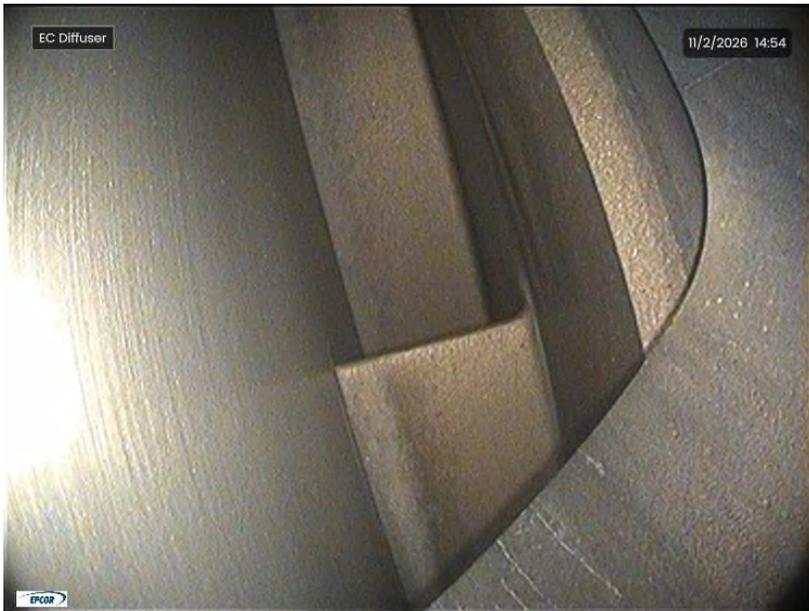
Engine\_Compressor\_EC\_Diffuser\_002.jpg

Module	Engine Compressor
Component	Compressor Diffuser
Findings	No obvious damage
Comments

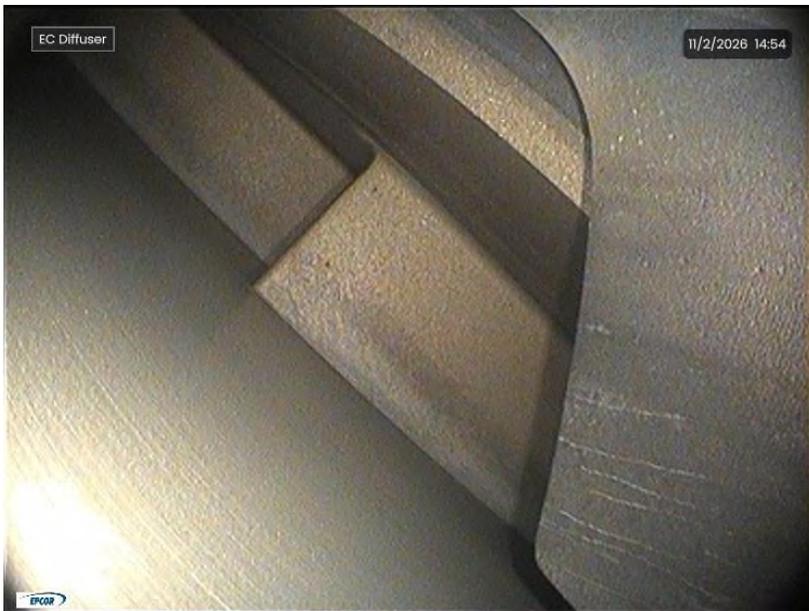
Engine\_Compressor\_EC\_Diffuser\_003.jpg

Module	Engine Compressor
Component	Compressor Diffuser
Findings	No obvious damage
Comments

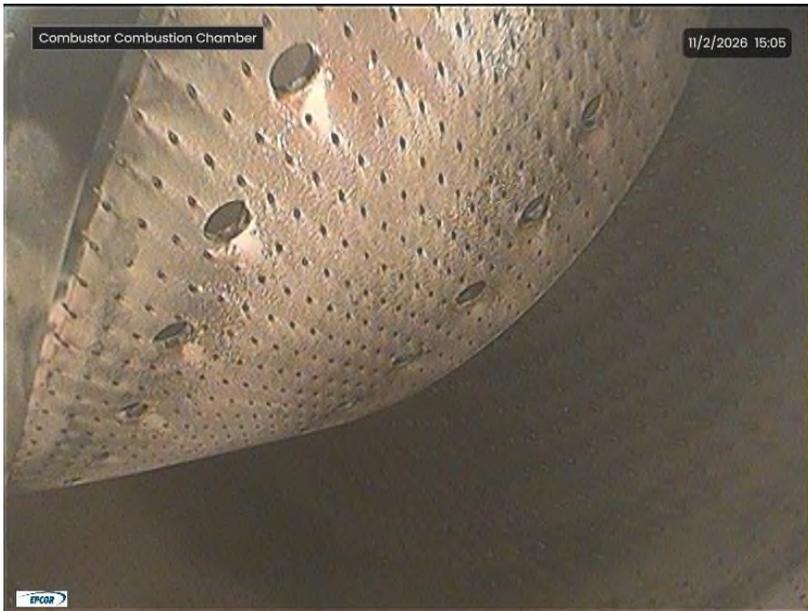
Combustor\_Combustion\_Chamber\_002.jpg

Module	Combustor
Component	Combustion Chamber
Findings	No obvious damage
Comments

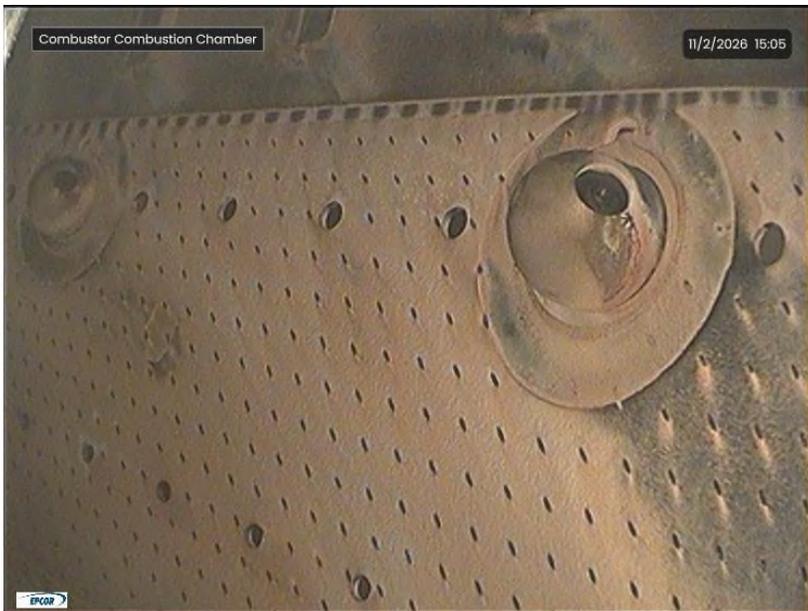
Combustor\_Combustion\_Chamber\_003.jpg

Module	Combustor
Component	Combustion Chamber
Findings	No obvious damage
Comments

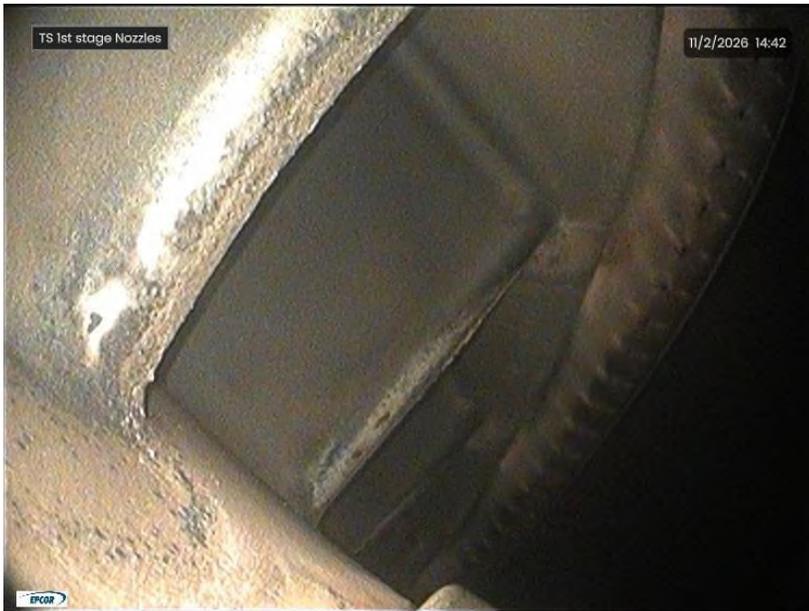
Turbine\_Section\_Turbine\_Nozzles\_002.jpg

Module	Turbine Section
Component	1st stage Turbine Nozzles
Findings	No obvious damage
Comments

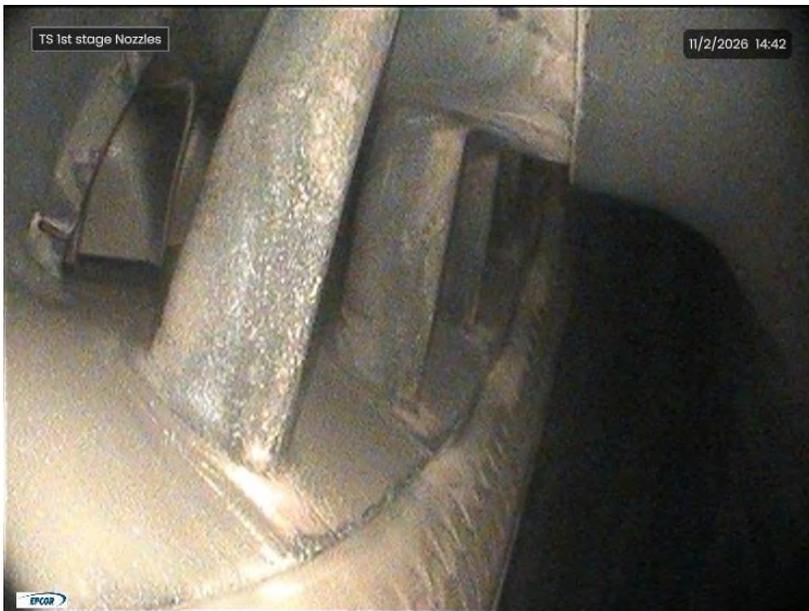
Turbine\_Section\_Turbine\_Nozzles\_003.jpg

Module	Turbine Section
Component	1st stage Turbine Nozzles
Findings	No obvious damage
Comments

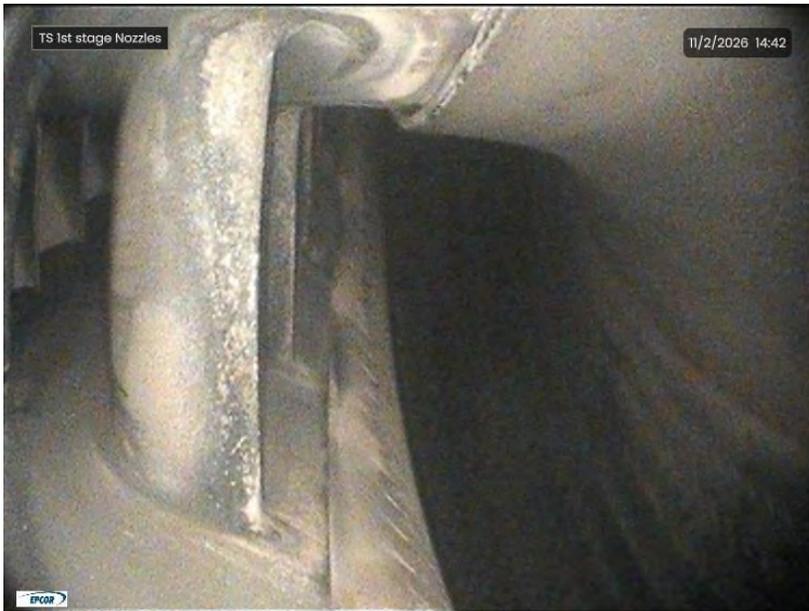
Turbine\_Section\_Turbine\_Nozzles\_004.jpg

Module	Turbine Section
Component	1st stage Turbine Nozzles
Findings	No obvious damage
Comments

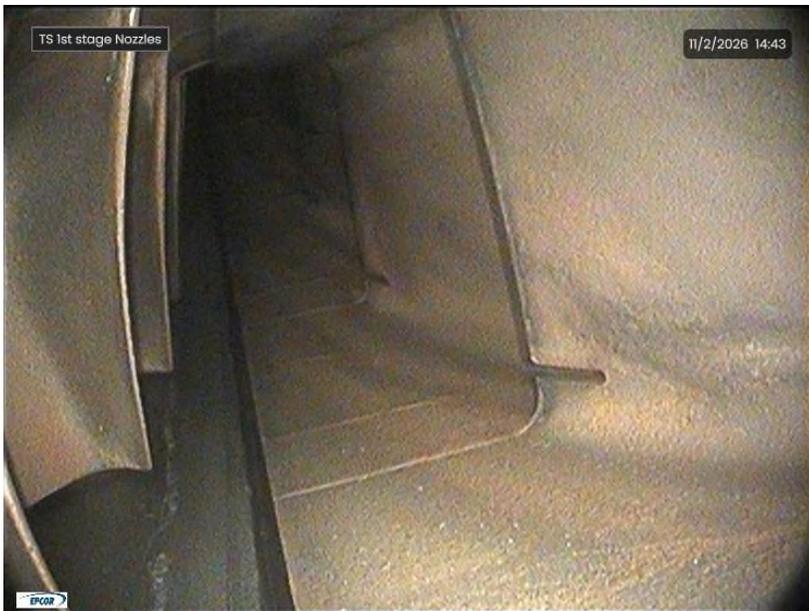
Turbine\_Section\_Turbine\_Nozzles\_005.jpg

Module	Turbine Section
Component	1st stage Turbine Nozzles
Findings	No obvious damage
Comments

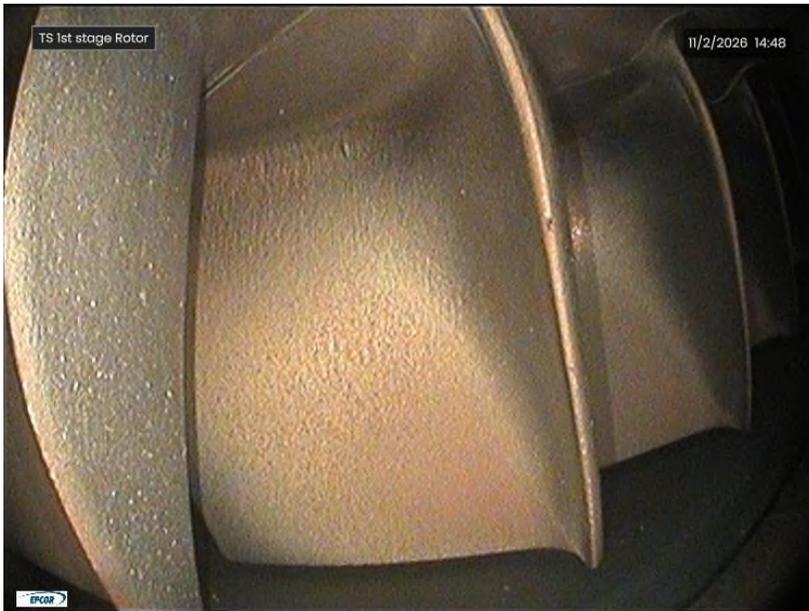
Turbine\_Section\_Turbine\_Rotor\_002.jpg

Module	Turbine Section
Component	1st stage Turbine Rotor
Findings	Small nick on the LE
Comments

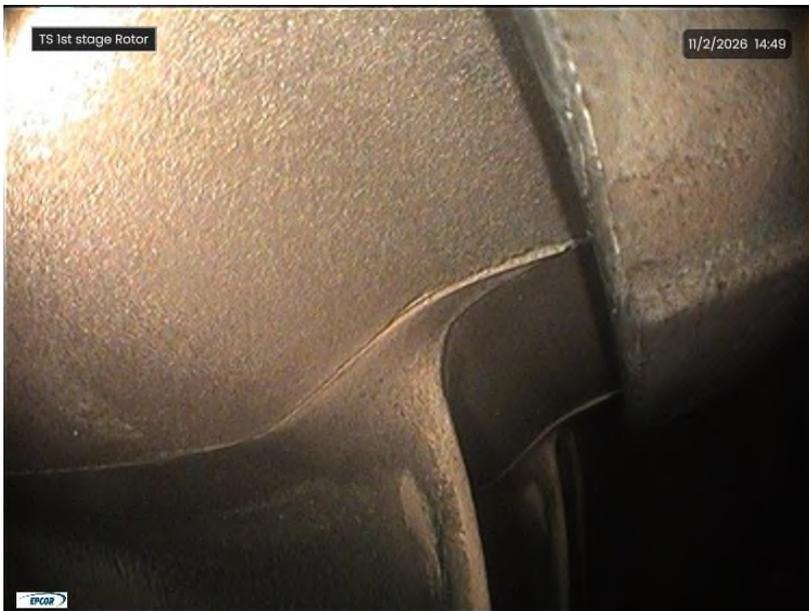
Turbine\_Section\_Turbine\_Rotor\_003.jpg

Module	Turbine Section
Component	1st stage Turbine Rotor
Findings	No obvious damage
Comments	No visible blade walk

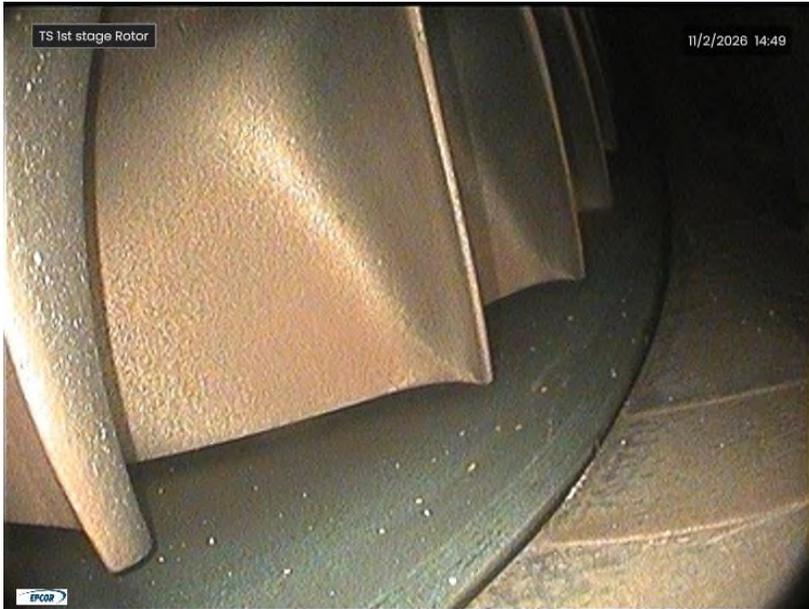
Turbine\_Section\_Turbine\_Rotor\_004.jpg

Module	Turbine Section
Component	1st stage Turbine Rotor
Findings	No obvious damage
Comments

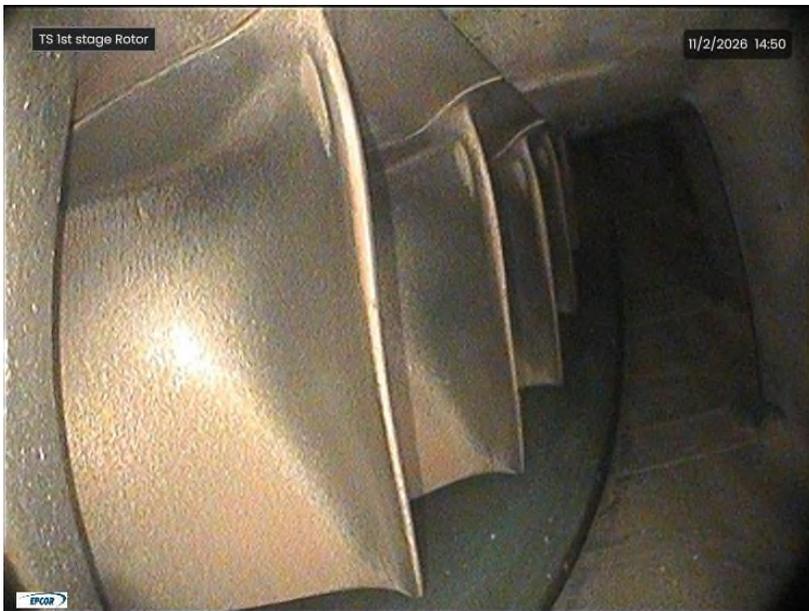
Turbine\_Section\_Turbine\_Rotor\_005.jpg

Module	Turbine Section
Component	1st stage Turbine Rotor
Findings	No obvious damage
Comments

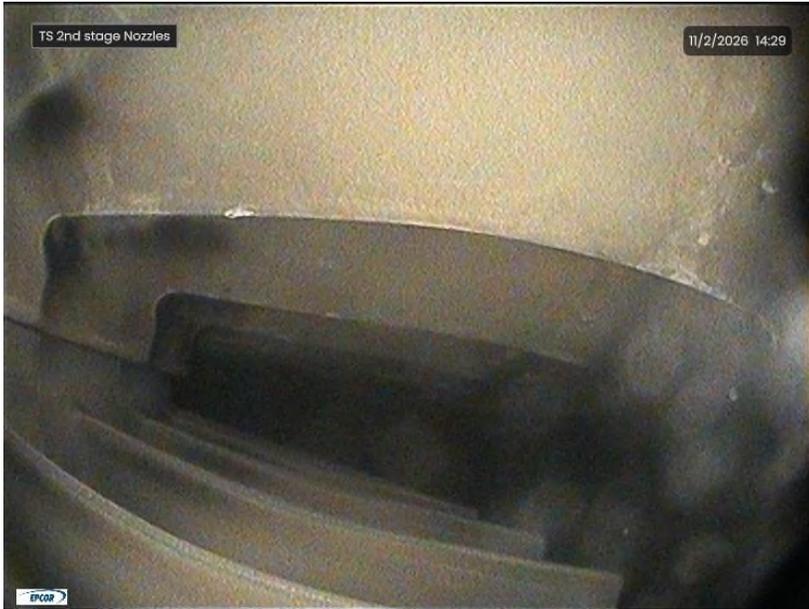
2nd\_stage\_Turbine\_Nozzles\_001.jpg

Module	Turbine Section
Component	2nd stage Turbine Nozzles
Findings	No obvious damage
Comments

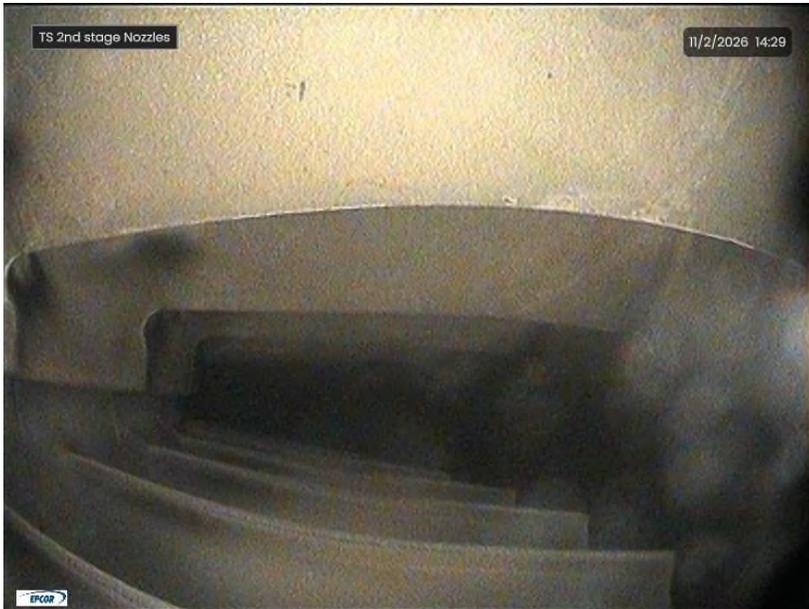
2nd\_stage\_Turbine\_Nozzles\_002.jpg

Module	Turbine Section
Component	2nd stage Turbine Nozzles
Findings	No obvious damage
Comments

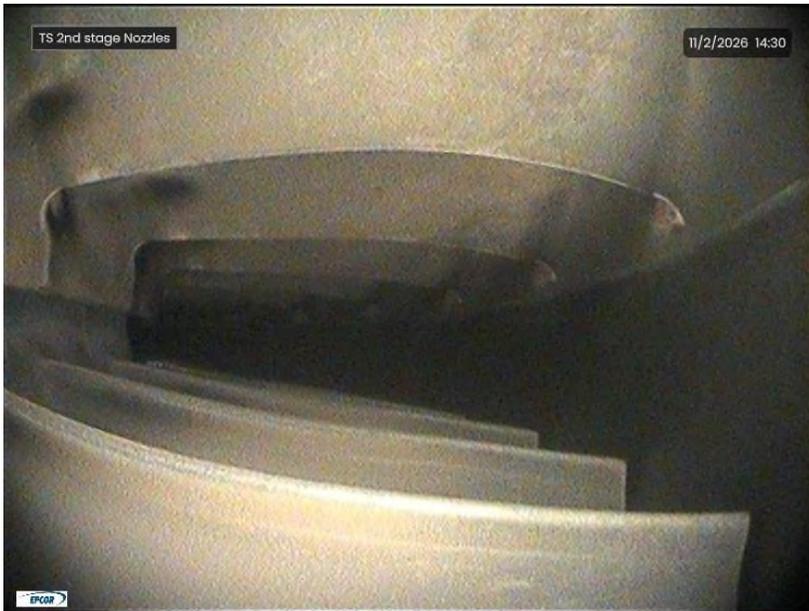
2nd\_stage\_Turbine\_Nozzles\_003.jpg

Module	Turbine Section
Component	2nd stage Turbine Nozzles
Findings	No obvious damage
Comments

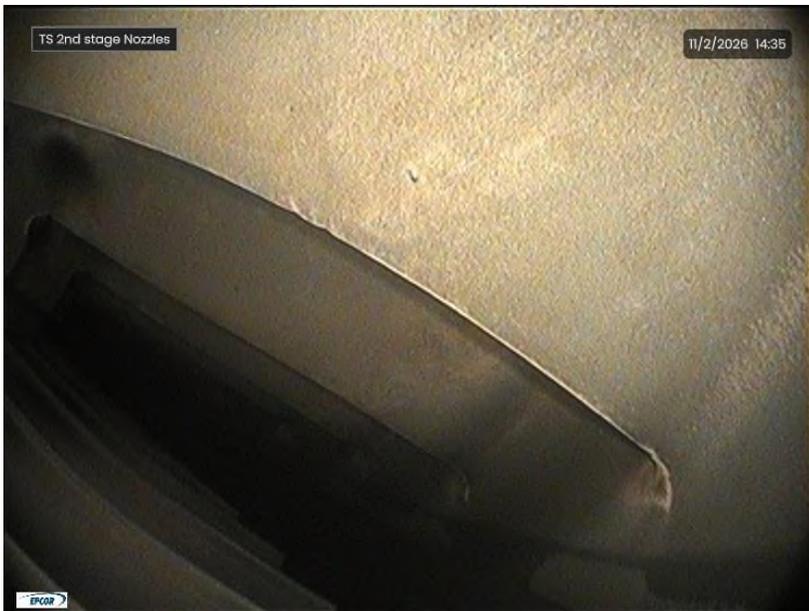
2nd\_stage\_Turbine\_Nozzles\_005.jpg

Module	Turbine Section
Component	2nd stage Turbine Nozzles
Findings	Nick on the TE
Comments

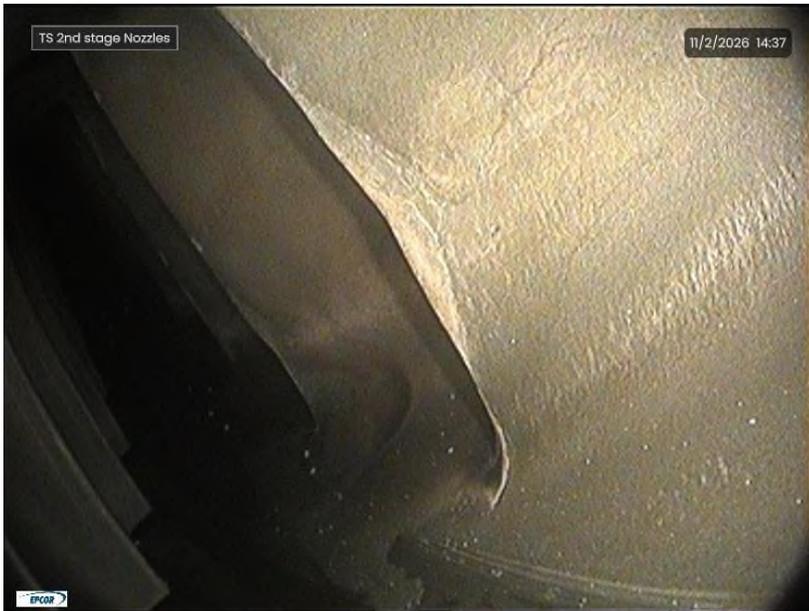
2nd\_stage\_Turbine\_Nozzles\_006.jpg

Module	Turbine Section
Component	2nd stage Turbine Nozzles
Findings	Minor damage on the TE
Comments

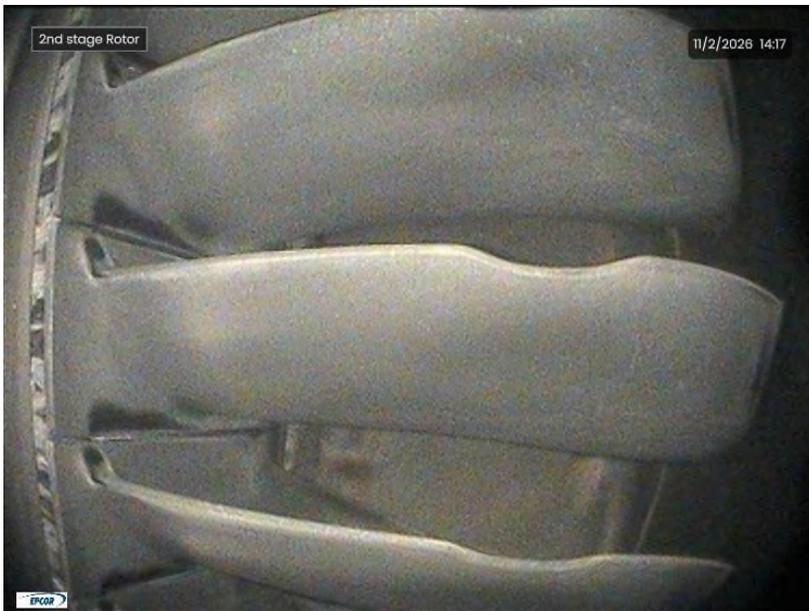
2nd\_stage\_Turbine\_Rotor\_002.jpg

Module	Turbine Section
Component	2nd stage Turbine Rotor
Findings	No obvious damage
Comments

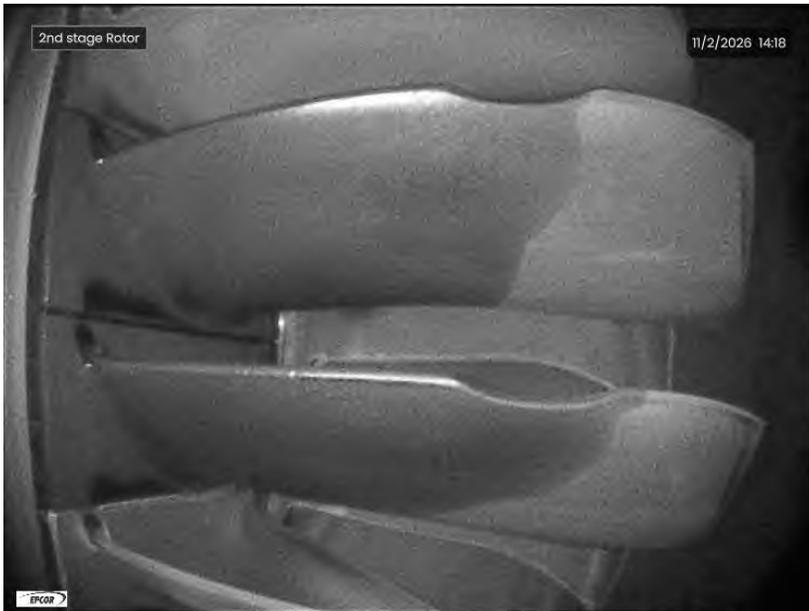
2nd\_stage\_Turbine\_Rotor\_003.jpg

Module	Turbine Section
Component	2nd stage Turbine Rotor
Findings	No obvious damage
Comments	Blades oil wetted

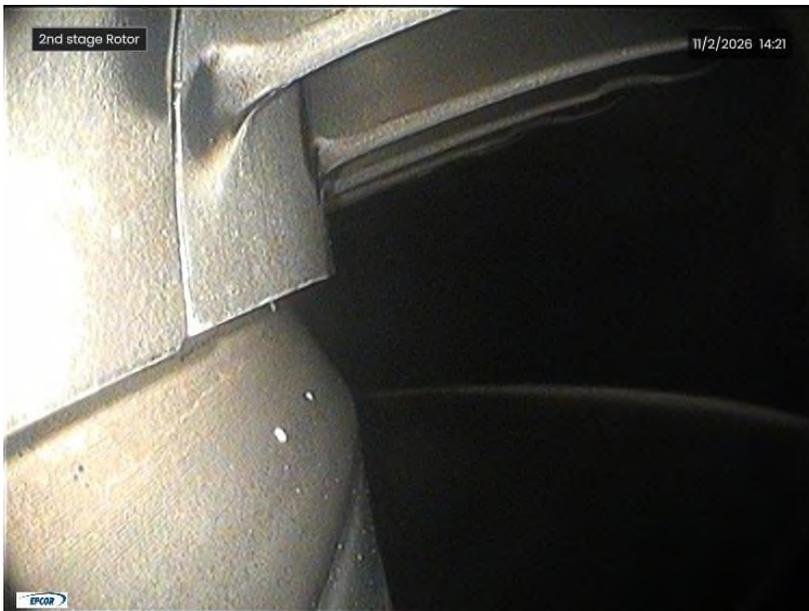
2nd\_stage\_Turbine\_Rotor\_004.jpg

Module	Turbine Section
Component	2nd stage Turbine Rotor
Findings	Minor blade walk
Comments

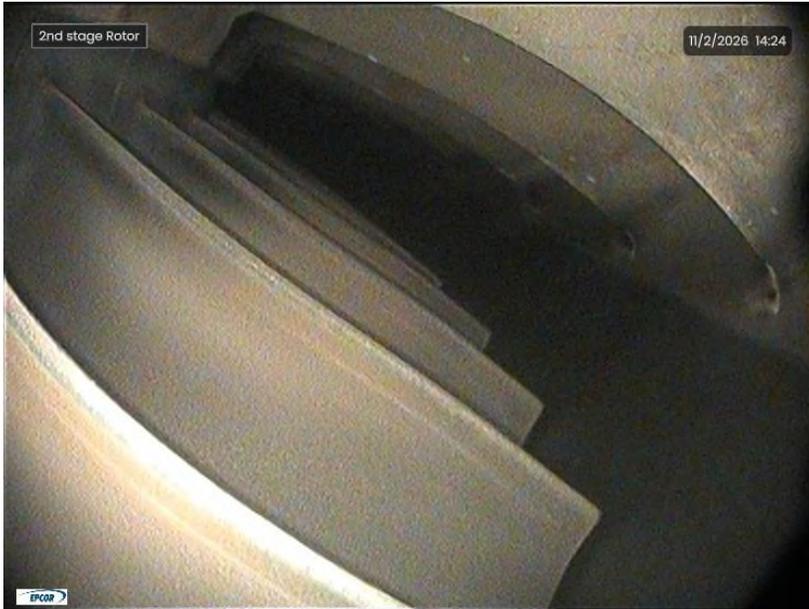
2nd\_stage\_Turbine\_Rotor\_006.jpg

Module	Turbine Section
Component	2nd stage Turbine Rotor
Findings	No obvious damage
Comments

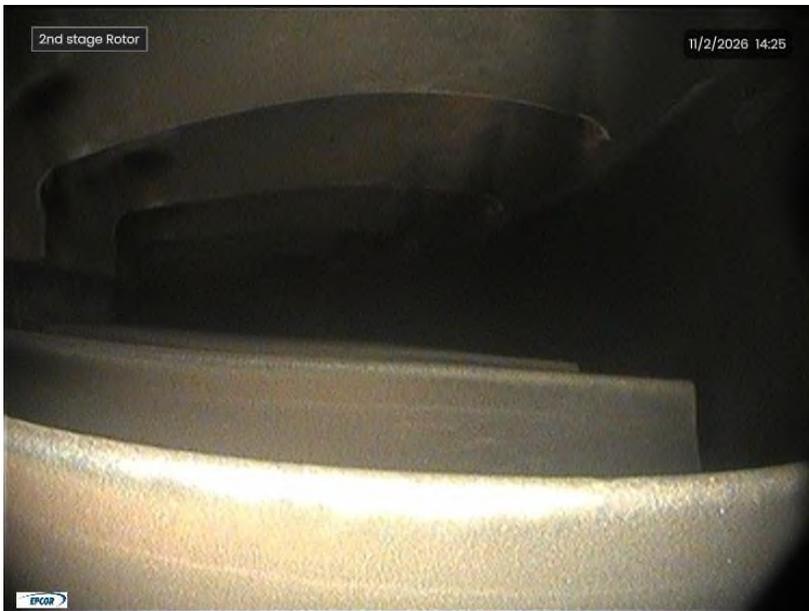
2nd\_stage\_Turbine\_Rotor\_007.jpg

Module	Turbine Section
Component	2nd stage Turbine Rotor
Findings	No obvious damage
Comments

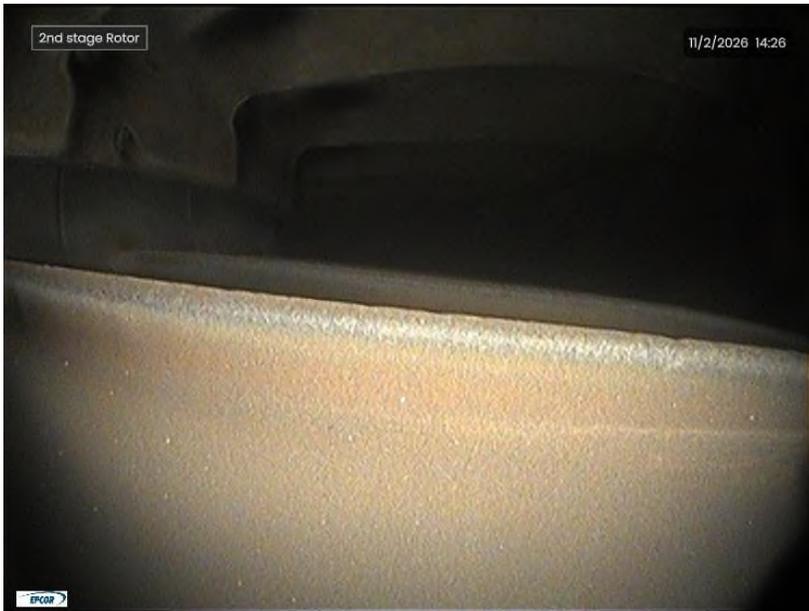
2nd\_stage\_Turbine\_Rotor\_009.jpg

Module	Turbine Section
Component	2nd stage Turbine Rotor
Findings	Small nick on the LE
Comments

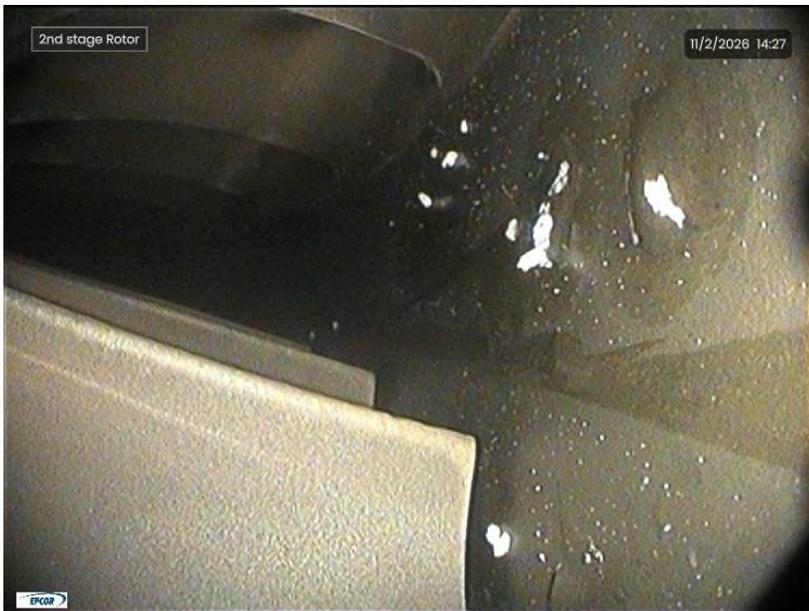
2nd\_stage\_Turbine\_Rotor\_010.jpg

Module	Turbine Section
Component	2nd stage Turbine Rotor
Findings	No obvious damage
Comments

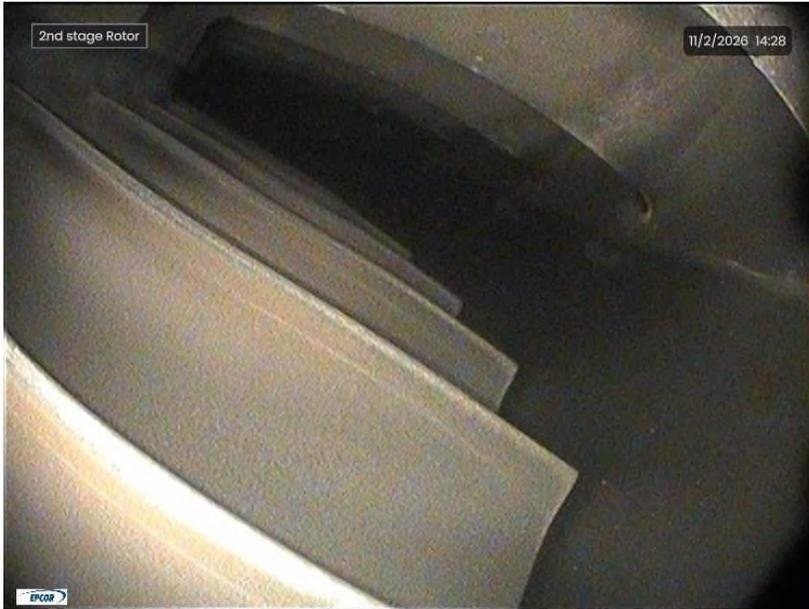
2nd\_stage\_Turbine\_Rotor\_011.jpg

Module	Turbine Section
Component	2nd stage Turbine Rotor
Findings	No obvious damage
Comments

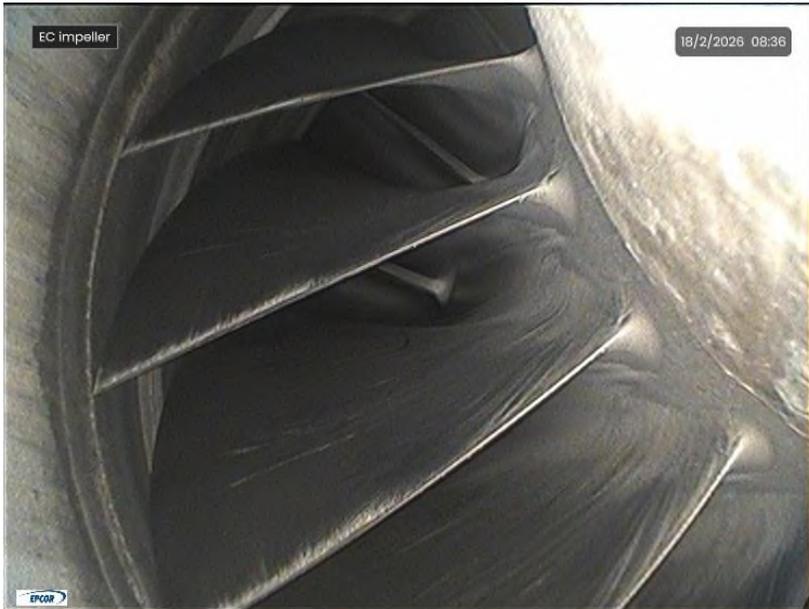
Engine\_Compressor\_EC\_impeller\_001.jpg

Module	Engine Compressor
Component	Compressor Impeller
Findings	No obvious damage
Comments

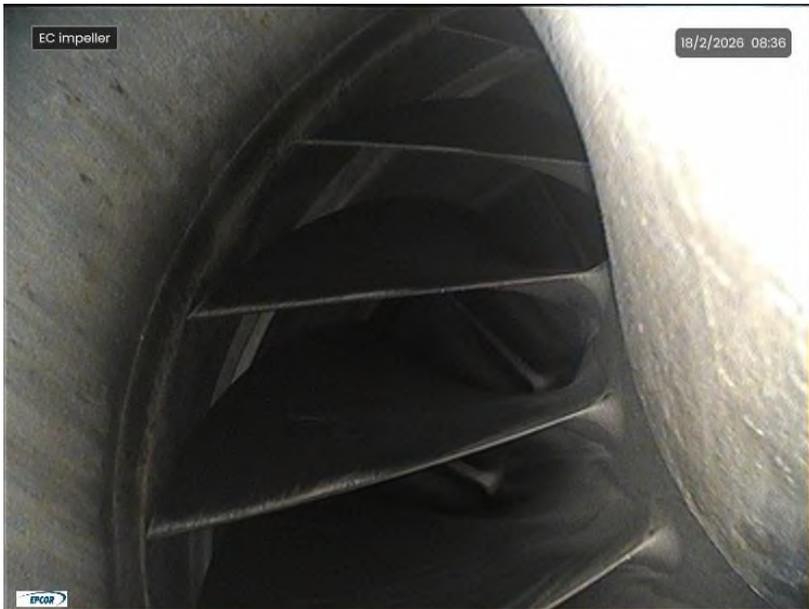
Engine\_Compressor\_EC\_impeller\_002.jpg

Module	Engine Compressor
Component	Compressor Impeller
Findings	No obvious damage
Comments

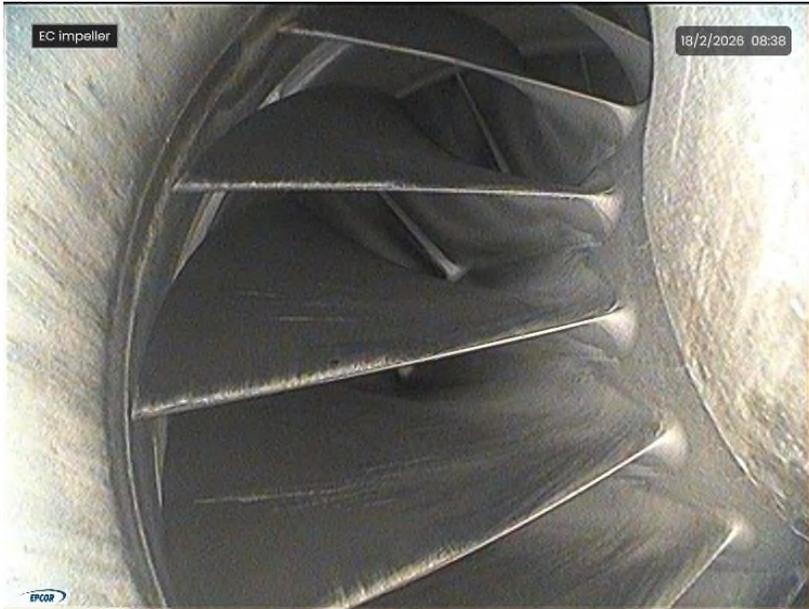
Engine\_Compressor\_EC\_impeller\_004.jpg

Module	Engine Compressor
Component	Compressor Impeller
Findings	No obvious damage
Comments

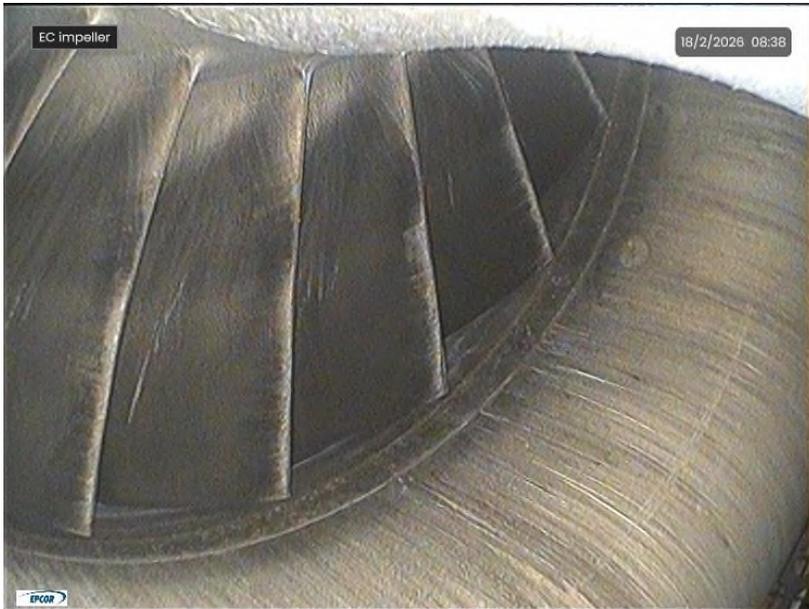
Engine\_Compressor\_EC\_impeller\_005.jpg

Module	Engine Compressor
Component	Compressor Impeller
Findings	No obvious damage
Comments

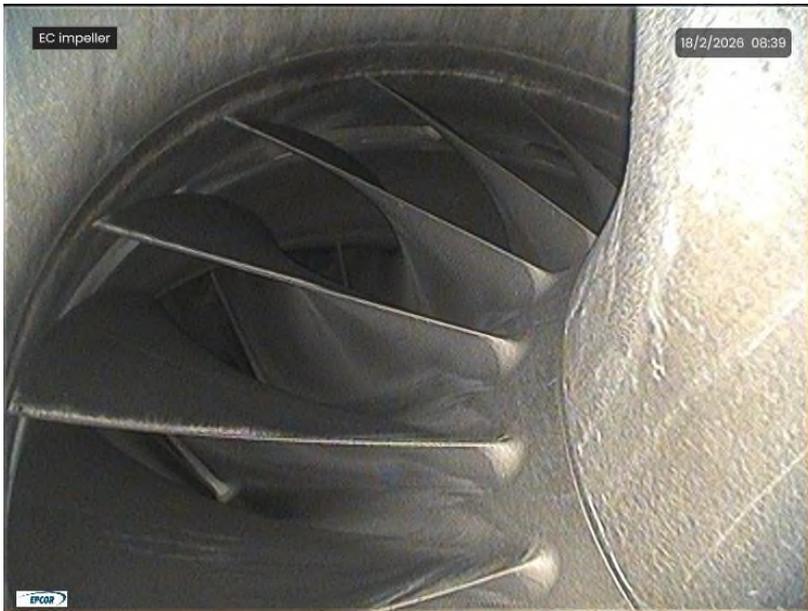
Engine\_Compressor\_EC\_impeller\_006.jpg

Module	Engine Compressor
Component	Compressor Impeller
Findings	No obvious damage
Comments

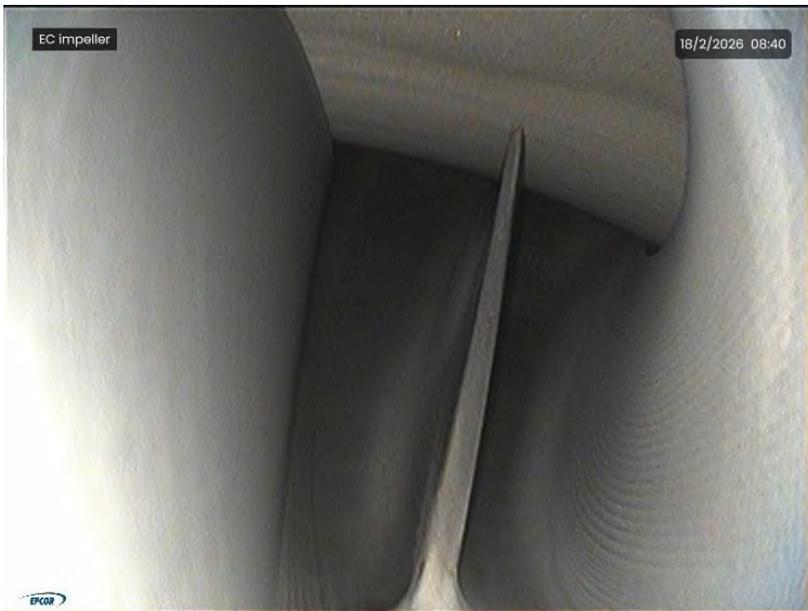
Engine\_Compressor\_EC\_impeller\_007.jpg

Module	Engine Compressor
Component	Compressor Impeller
Findings	No obvious damage
Comments

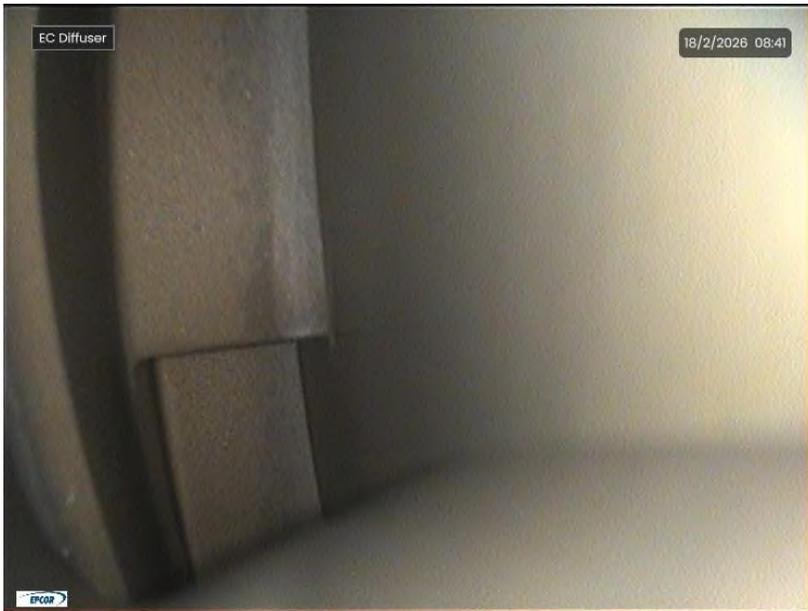
Engine\_Compressor\_EC\_Diffuser\_001.jpg

Module	Engine Compressor
Component	Compressor Diffuser
Findings	No obvious damage
Comments

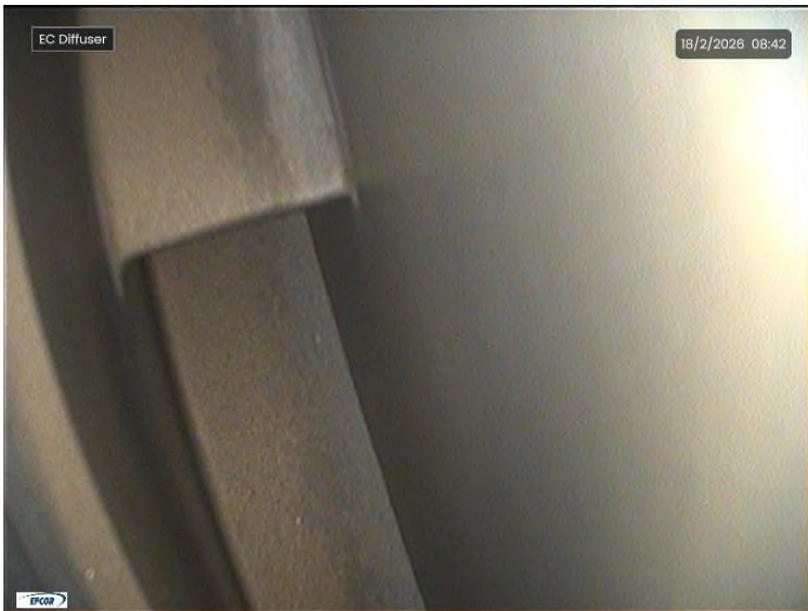
Engine\_Compressor\_EC\_Diffuser\_002.jpg

Module	Engine Compressor
Component	Compressor Diffuser
Findings	No obvious damage
Comments

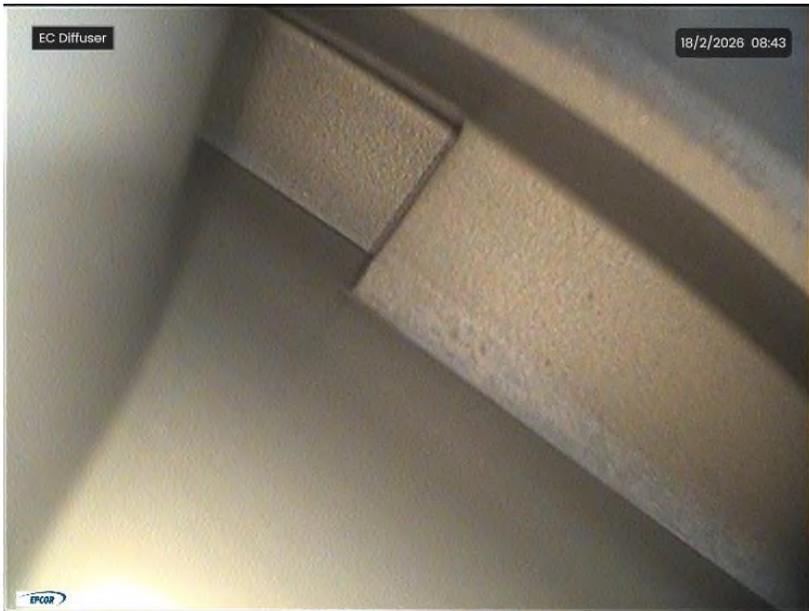
Engine\_Compressor\_EC\_Diffuser\_004.jpg

Module	Engine Compressor
Component	Compressor Diffuser
Findings	No obvious damage
Comments

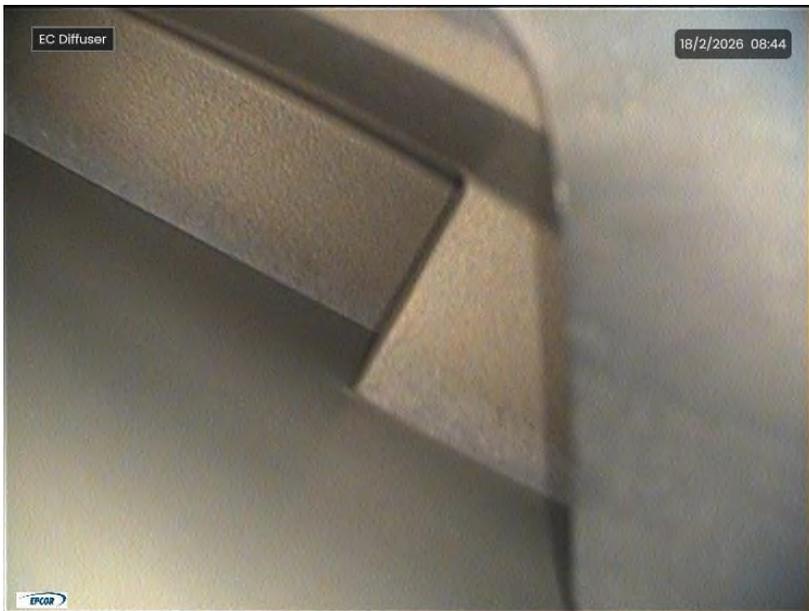
Engine\_Compressor\_EC\_Diffuser\_005.jpg

Module	Engine Compressor
Component	Compressor Diffuser
Findings	No obvious damage
Comments

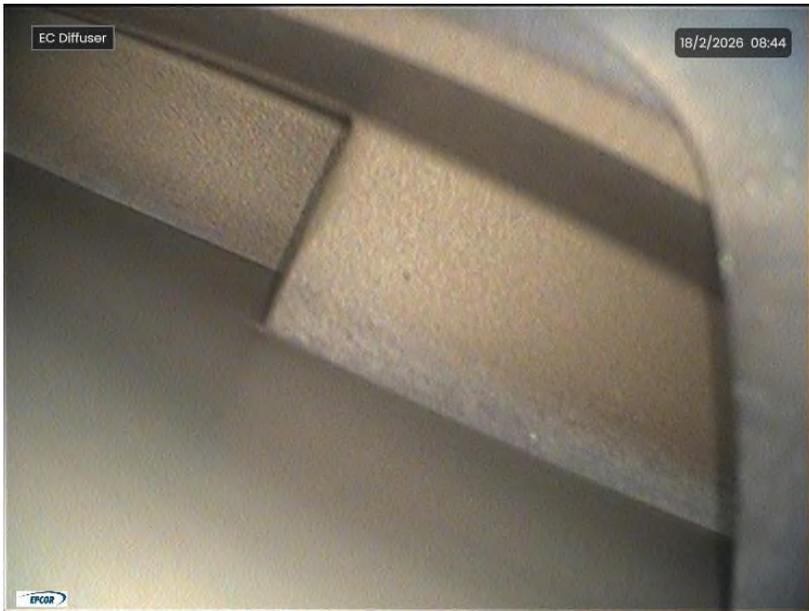
Engine\_Compressor\_EC\_Diffuser\_006.jpg

Module	Engine Compressor
Component	Compressor Diffuser
Findings	No obvious damage
Comments

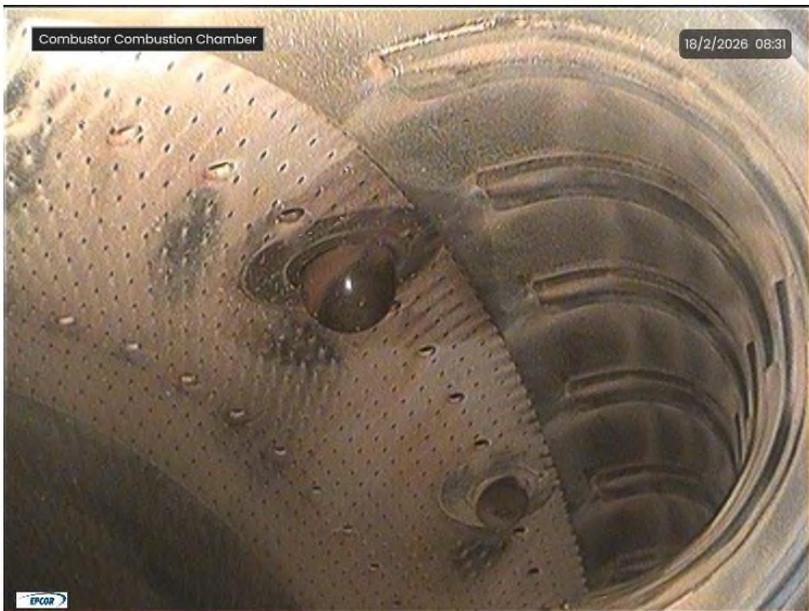
Combustor\_Combustion\_Chamber\_001.jpg

Module	Combustor
Component	Combustion Chamber
Findings	No obvious damage
Comments
