## APU Service Record

<b>APU Type</b> APS5000A	<b>APU P/N</b> 7002907H05	<b>APU S/N</b> HSC-E1525347PL
TSN : 1137	TSO: UNK	TSR : 1137
		CSN : 1659
		CSO: UNK
		CSR : 1659

# Shop Findings Report

W0021262

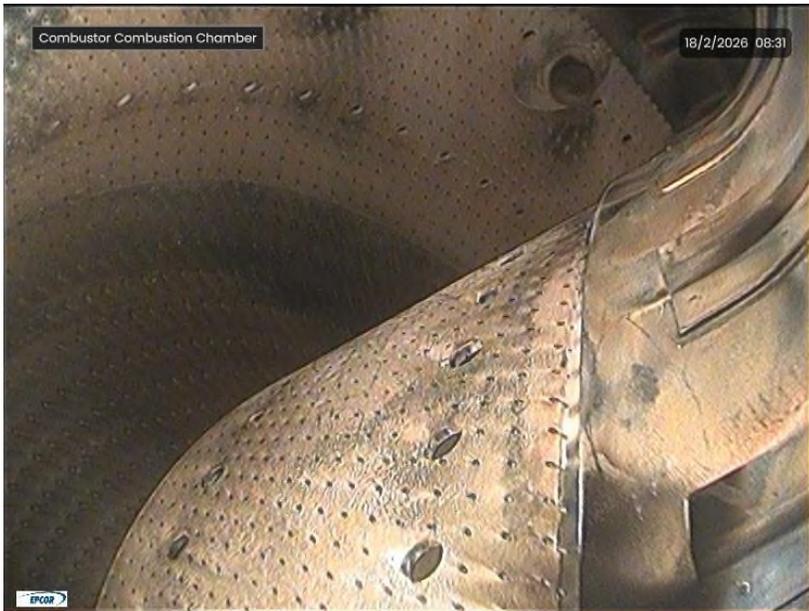
Combustor\_Combustion\_Chamber\_002.jpg

Module	Combustor
Component	Combustion Chamber
Findings	No obvious damage
Comments

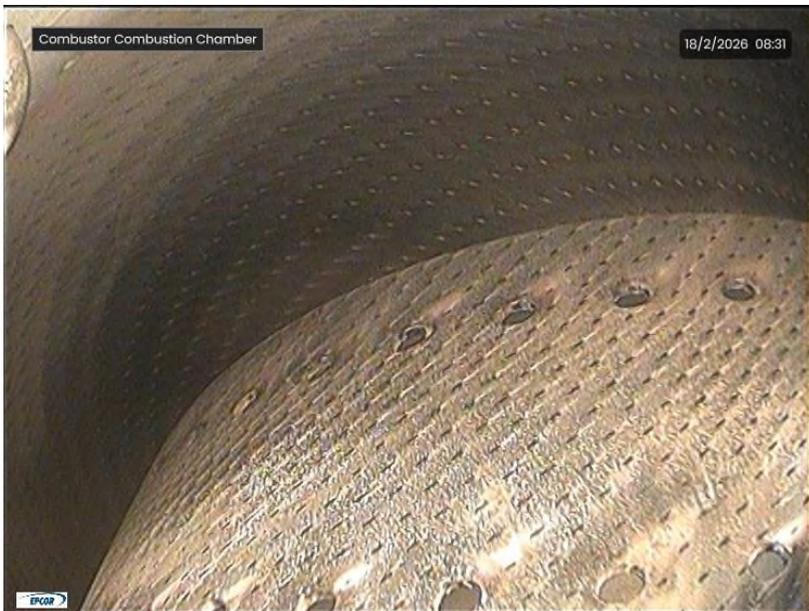
Combustor\_Combustion\_Chamber\_003.jpg

Module	Combustor
Component	Combustion Chamber
Findings	No obvious damage
Comments

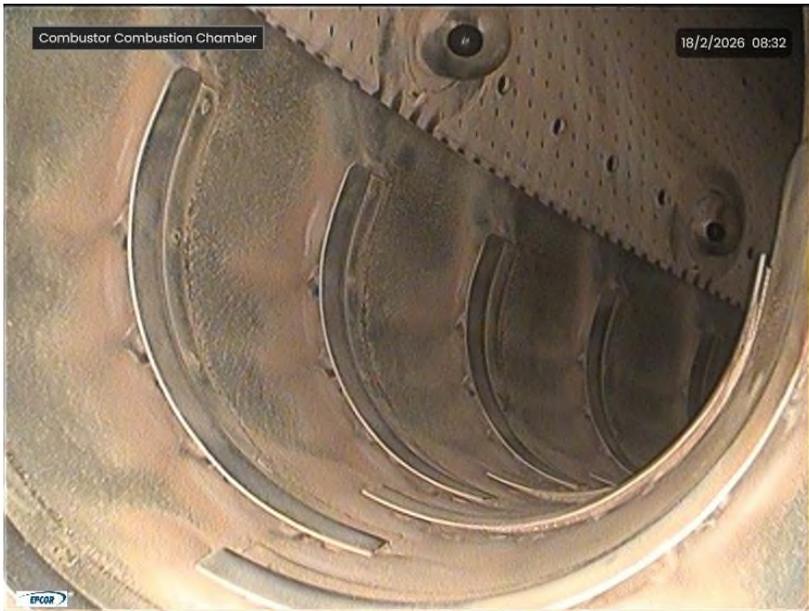
Combustor\_Combustion\_Chamber\_004.jpg

Module	Combustor
Component	Combustion Chamber
Findings	No obvious damage
Comments

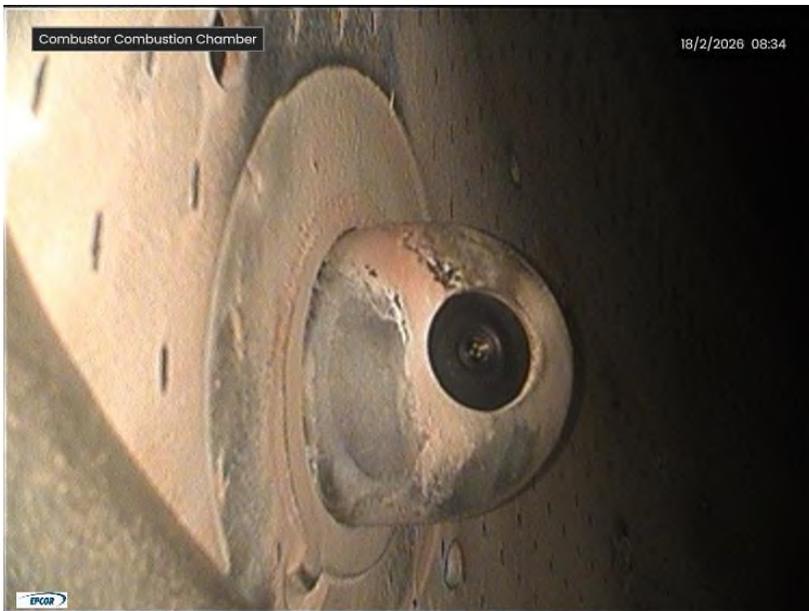
Combustor\_Combustion\_Chamber\_006.jpg

Module	Combustor
Component	Combustion Chamber
Findings	No obvious damage
Comments

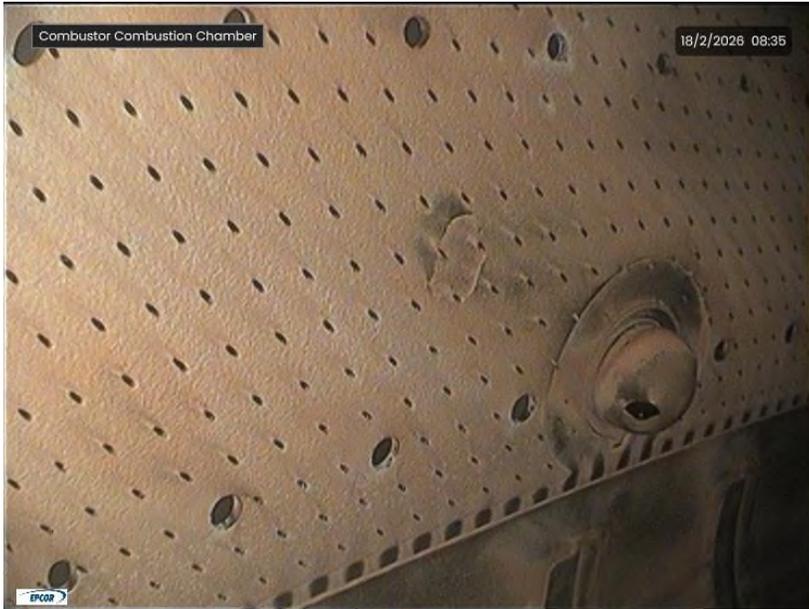
Combustor\_Combustion\_Chamber\_007.jpg

Module	Combustor
Component	Combustion Chamber
Findings	No obvious damage
Comments

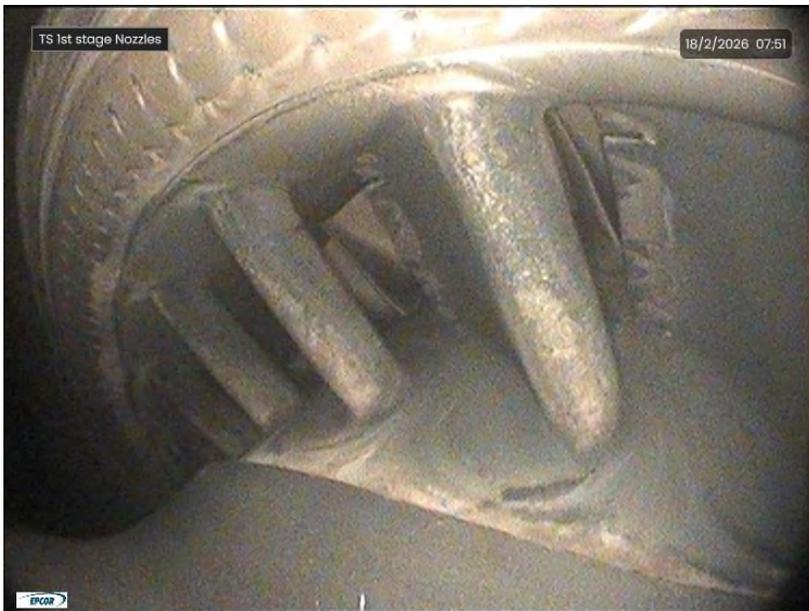
Turbine\_Section\_Turbine\_Nozzles\_001.jpg

Module	Turbine Section
Component	1st stage Turbine Nozzles
Findings	No obvious damage
Comments

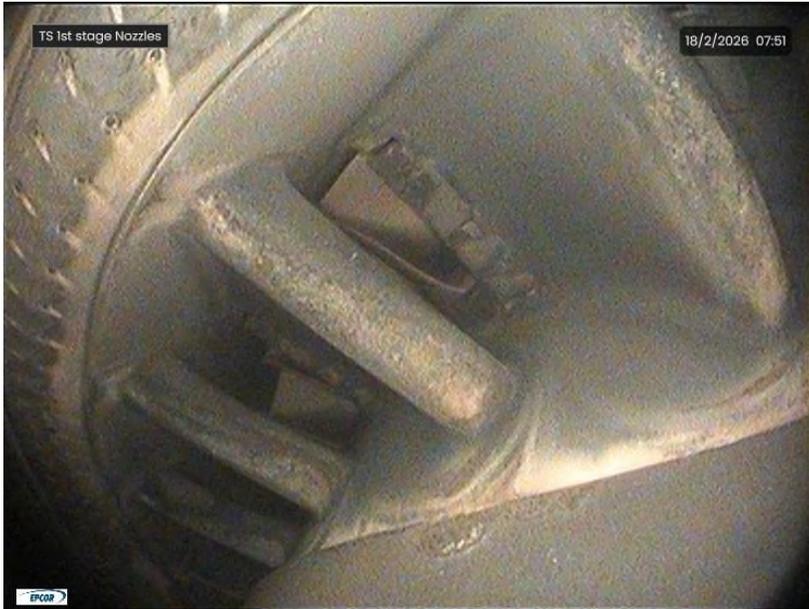
Turbine\_Section\_Turbine\_Nozzles\_002.jpg

Module	Turbine Section
Component	1st stage Turbine Nozzles
Findings	No obvious damage
Comments

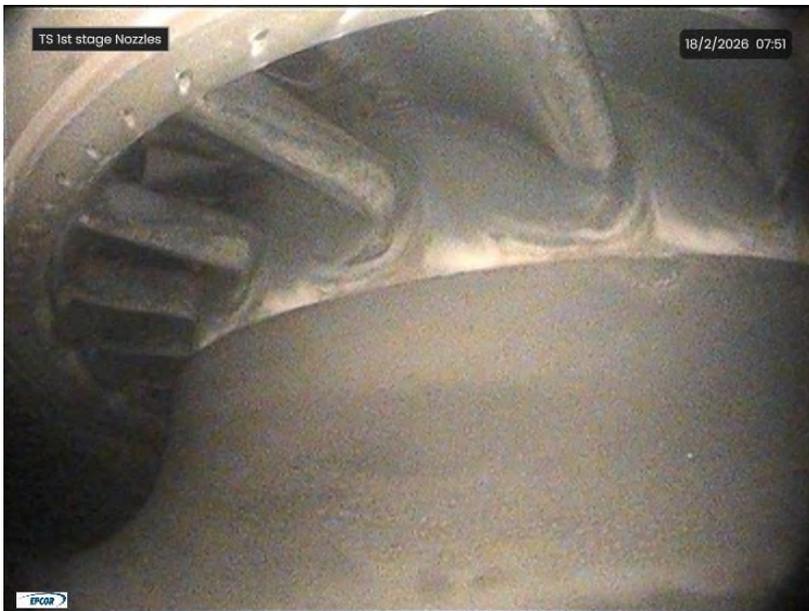
Turbine\_Section\_Turbine\_Nozzles\_003.jpg

Module	Turbine Section
Component	1st stage Turbine Nozzles
Findings	No obvious damage
Comments

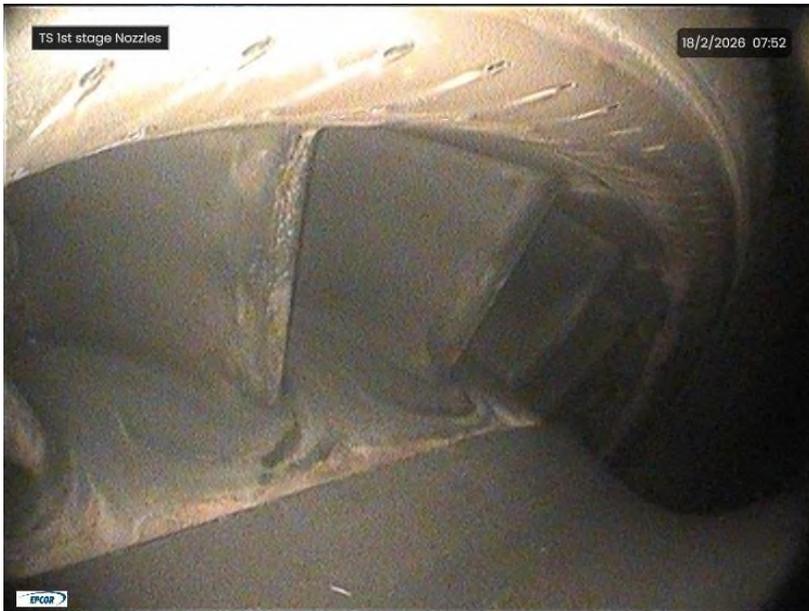
Turbine\_Section\_Turbine\_Nozzles\_004.jpg

Module	Turbine Section
Component	1st stage Turbine Nozzles
Findings	No obvious damage
Comments

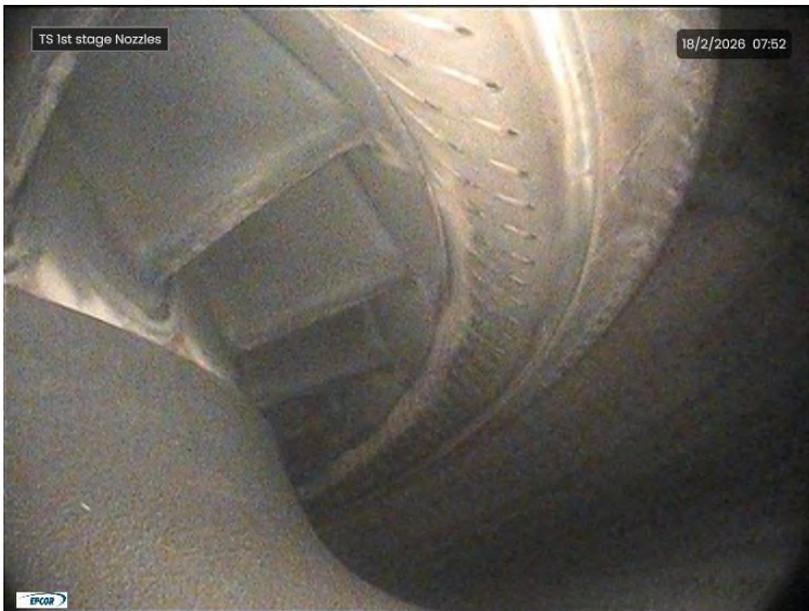
Turbine\_Section\_Turbine\_Nozzles\_005.jpg

Module	Turbine Section
Component	1st stage Turbine Nozzles
Findings	No obvious damage
Comments

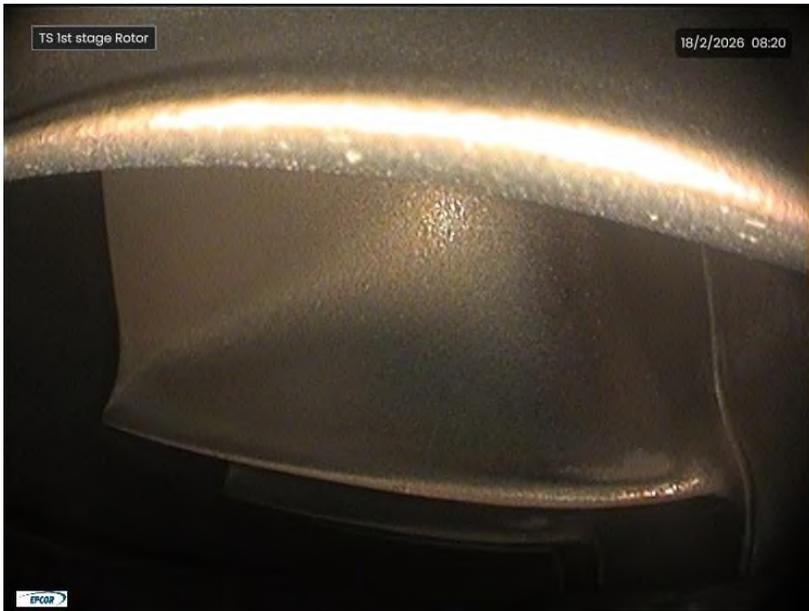
Turbine\_Section\_Turbine\_Rotor\_002.jpg

Module	Turbine Section
Component	1st stage Turbine Rotor
Findings	No obvious damage
Comments

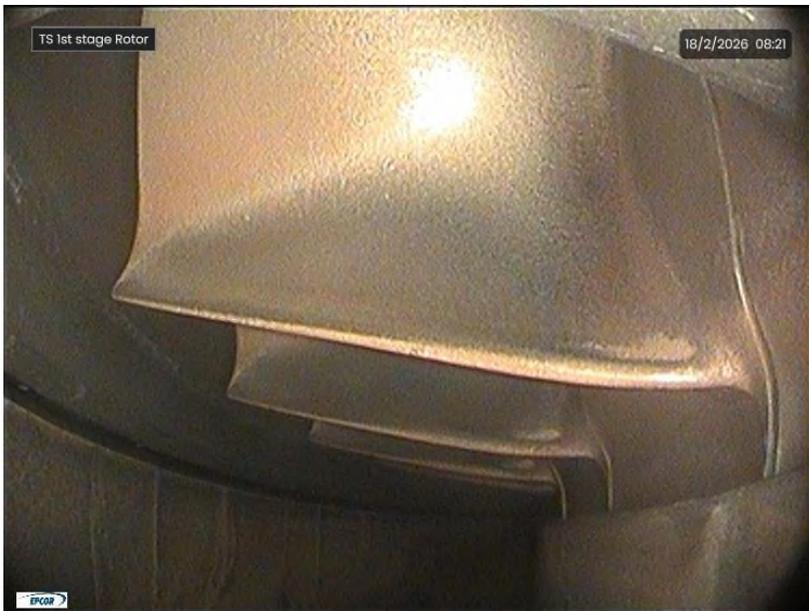
Turbine\_Section\_Turbine\_Rotor\_003.jpg

Module	Turbine Section
Component	1st stage Turbine Rotor
Findings	No obvious damage
Comments

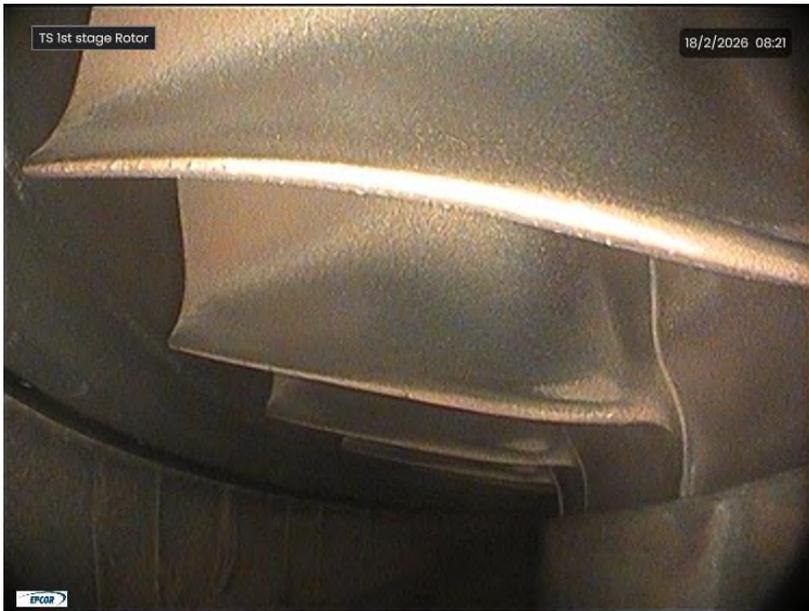
Turbine\_Section\_Turbine\_Rotor\_004.jpg

Module	Turbine Section
Component	1st stage Turbine Rotor
Findings	No obvious damage
Comments

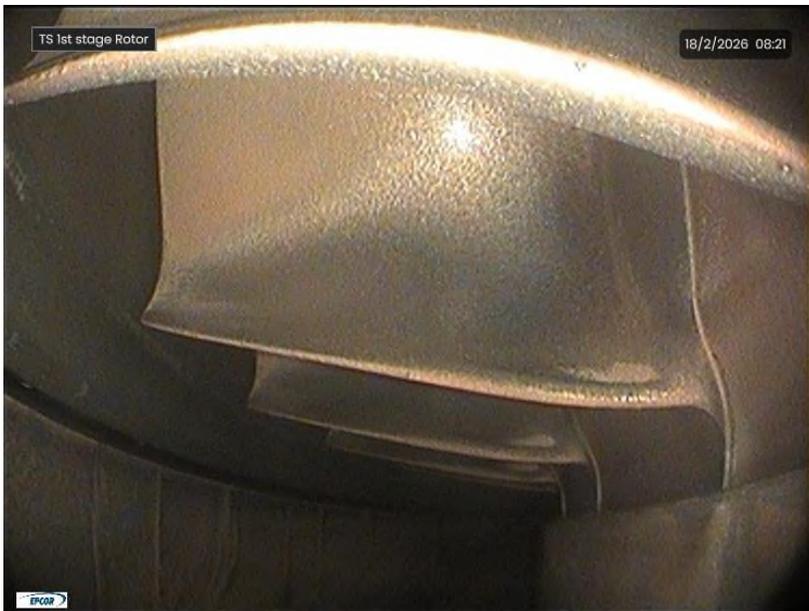
Turbine\_Section\_Turbine\_Rotor\_005.jpg

Module	Turbine Section
Component	1st stage Turbine Rotor
Findings	No obvious damage
Comments

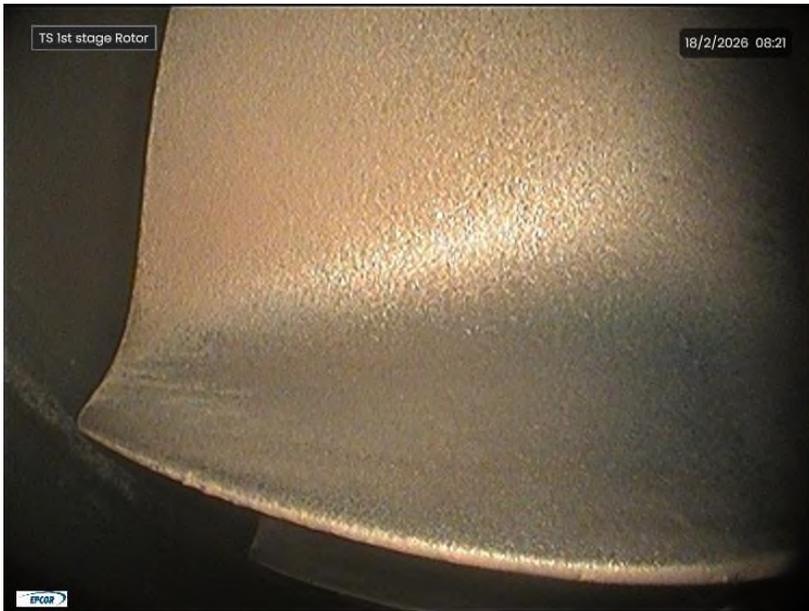
Turbine\_Section\_Turbine\_Rotor\_006.jpg

Module	Turbine Section
Component	1st stage Turbine Rotor
Findings	No obvious damage
Comments

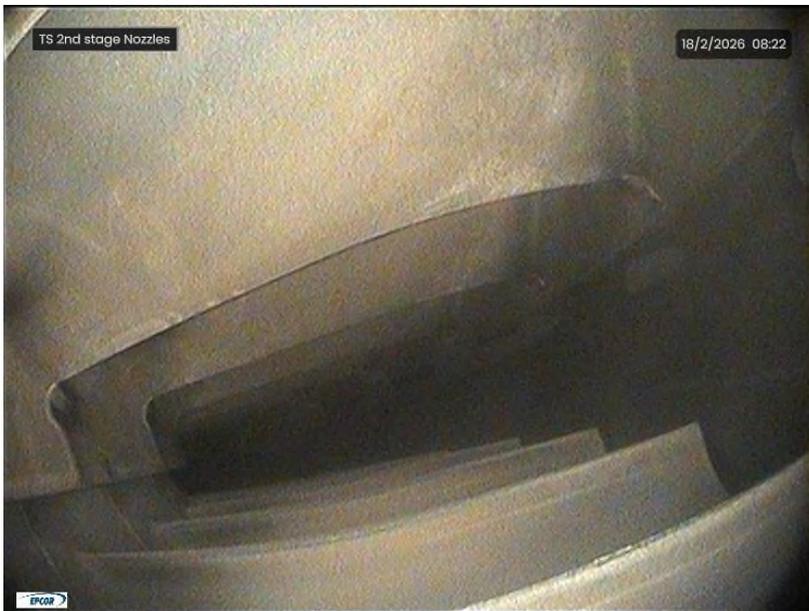
2nd\_stage\_Turbine\_Nozzles\_001.jpg

Module	Turbine Section
Component	2nd stage Turbine Nozzles
Findings	No obvious damage
Comments

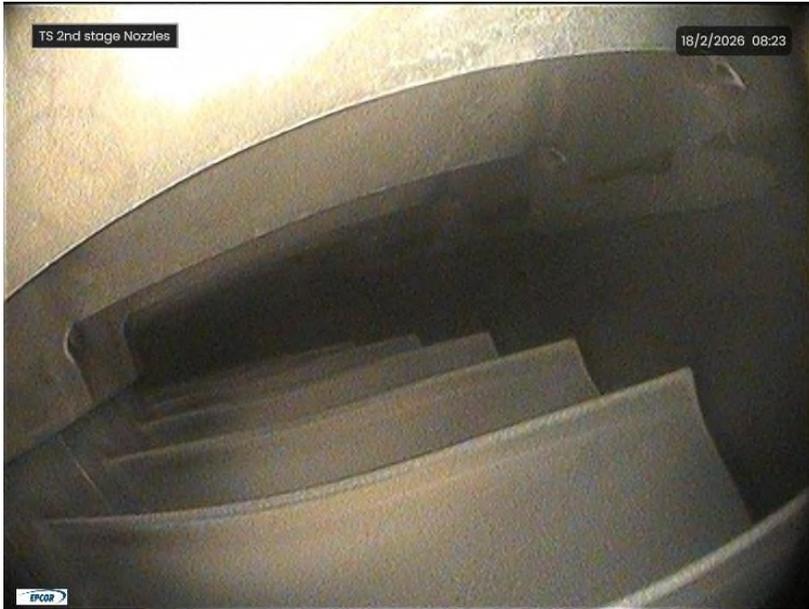
2nd\_stage\_Turbine\_Nozzles\_002.jpg

Module	Turbine Section
Component	2nd stage Turbine Nozzles
Findings	No obvious damage
Comments

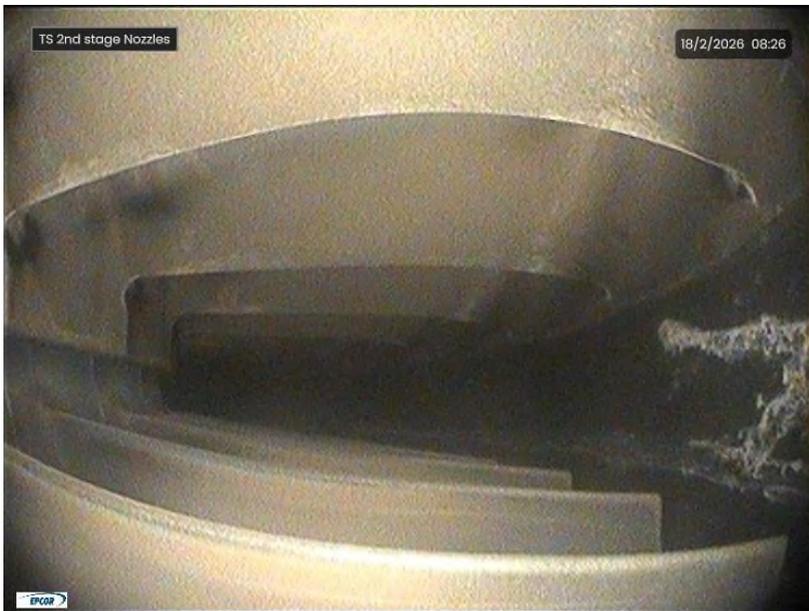
2nd\_stage\_Turbine\_Nozzles\_004.jpg

Module	Turbine Section
Component	2nd stage Turbine Nozzles
Findings	No obvious damage
Comments

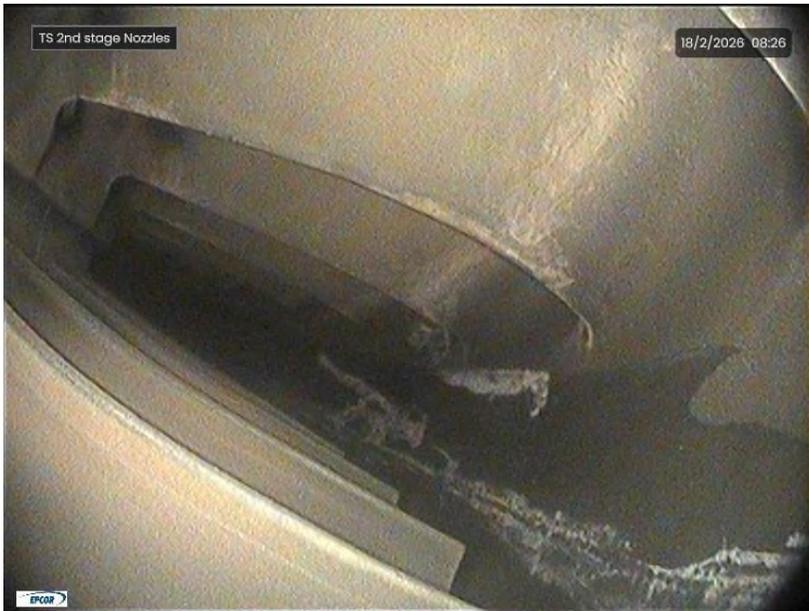
2nd\_stage\_Turbine\_Nozzles\_005.jpg

Module	Turbine Section
Component	2nd stage Turbine Nozzles
Findings	No obvious damage
Comments

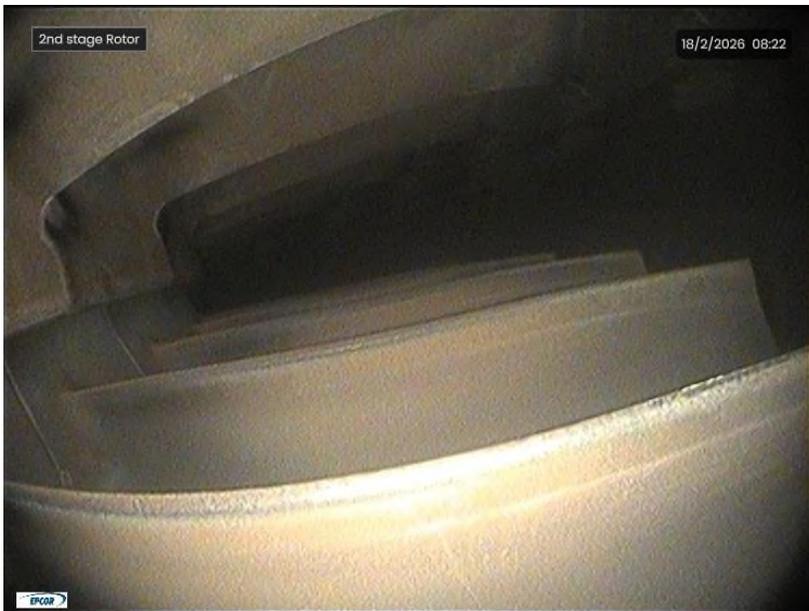
2nd\_stage\_Turbine\_Rotor\_001.jpg

Module	Turbine Section
Component	2nd stage Turbine Rotor
Findings	No obvious damage
Comments

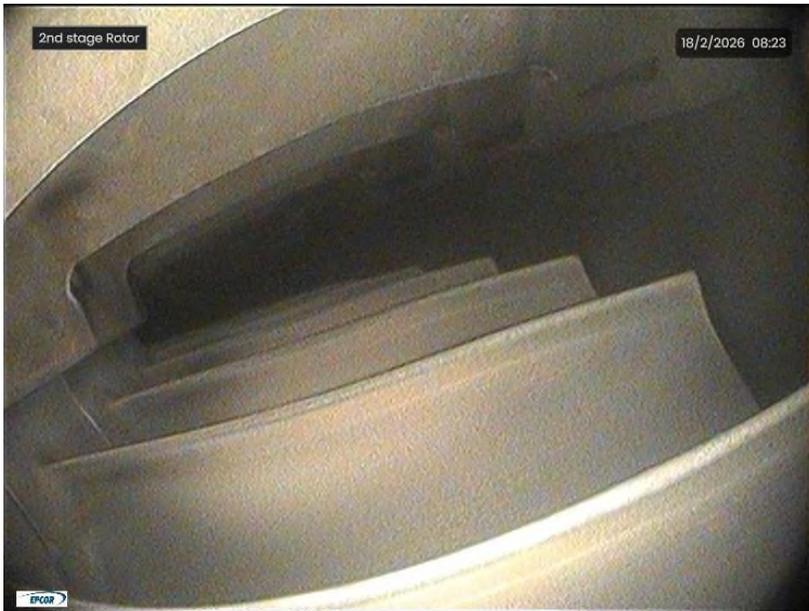
2nd\_stage\_Turbine\_Rotor\_002.jpg

Module	Turbine Section
Component	2nd stage Turbine Rotor
Findings	No obvious damage
Comments

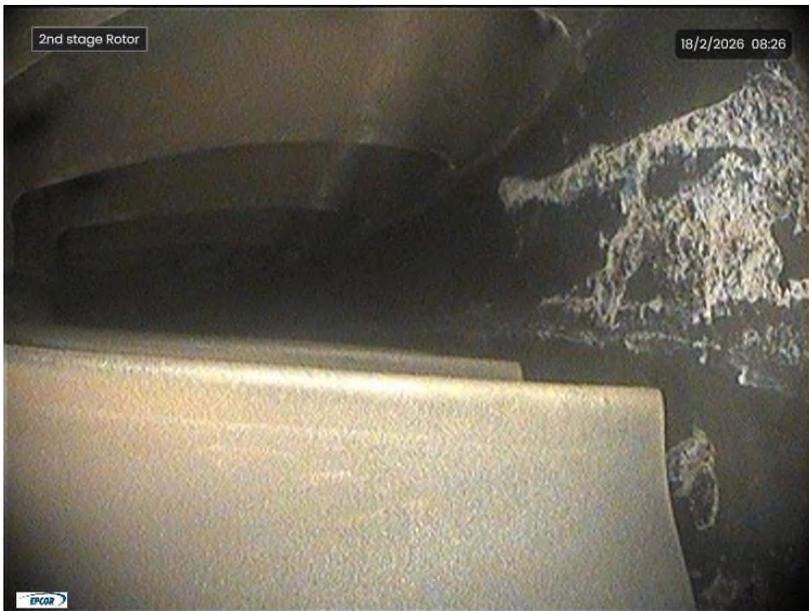
2nd\_stage\_Turbine\_Rotor\_003.jpg

Module	Turbine Section
Component	2nd stage Turbine Rotor
Findings	No obvious damage
Comments

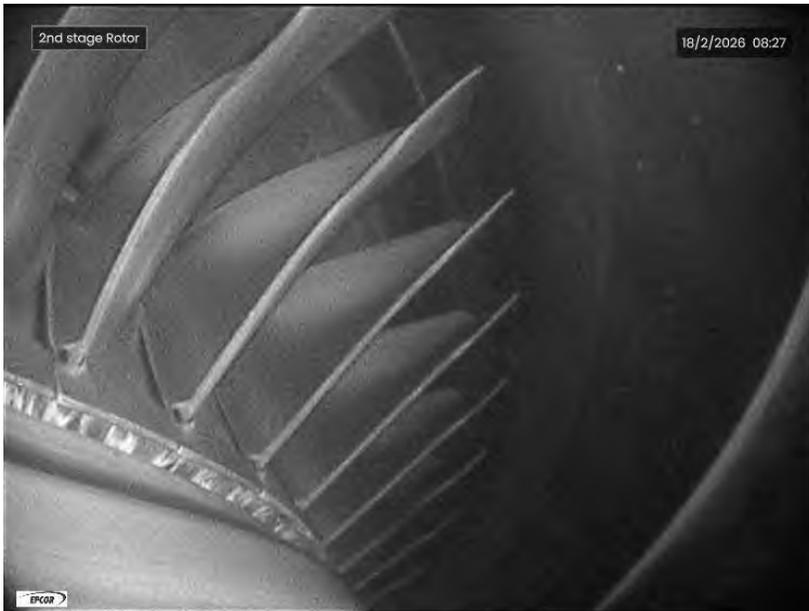
2nd\_stage\_Turbine\_Rotor\_004.jpg

Module	Turbine Section
Component	2nd stage Turbine Rotor
Findings	No obvious damage
Comments

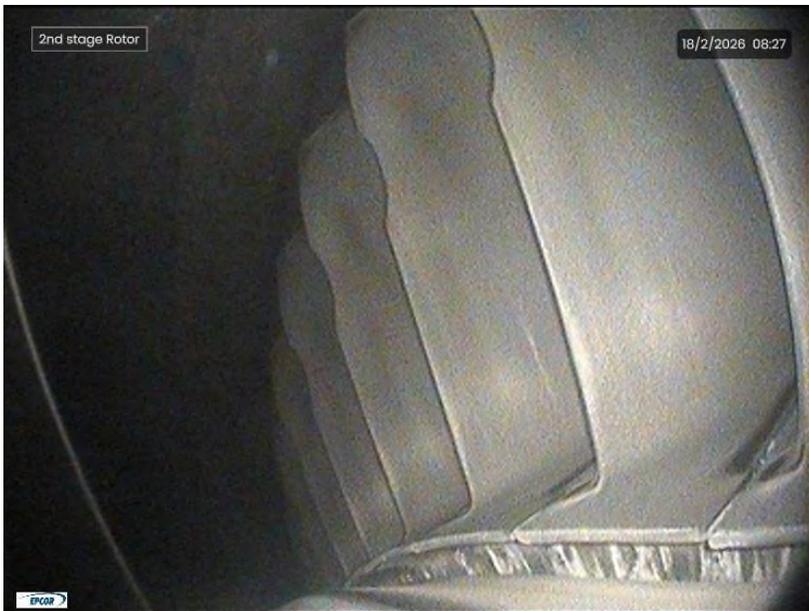
2nd\_stage\_Turbine\_Rotor\_005.jpg

Module	Turbine Section
Component	2nd stage Turbine Rotor
Findings	No obvious damage
Comments
