GE 90 Inlet Cowl

001114

314W1400-9

REPAIRED

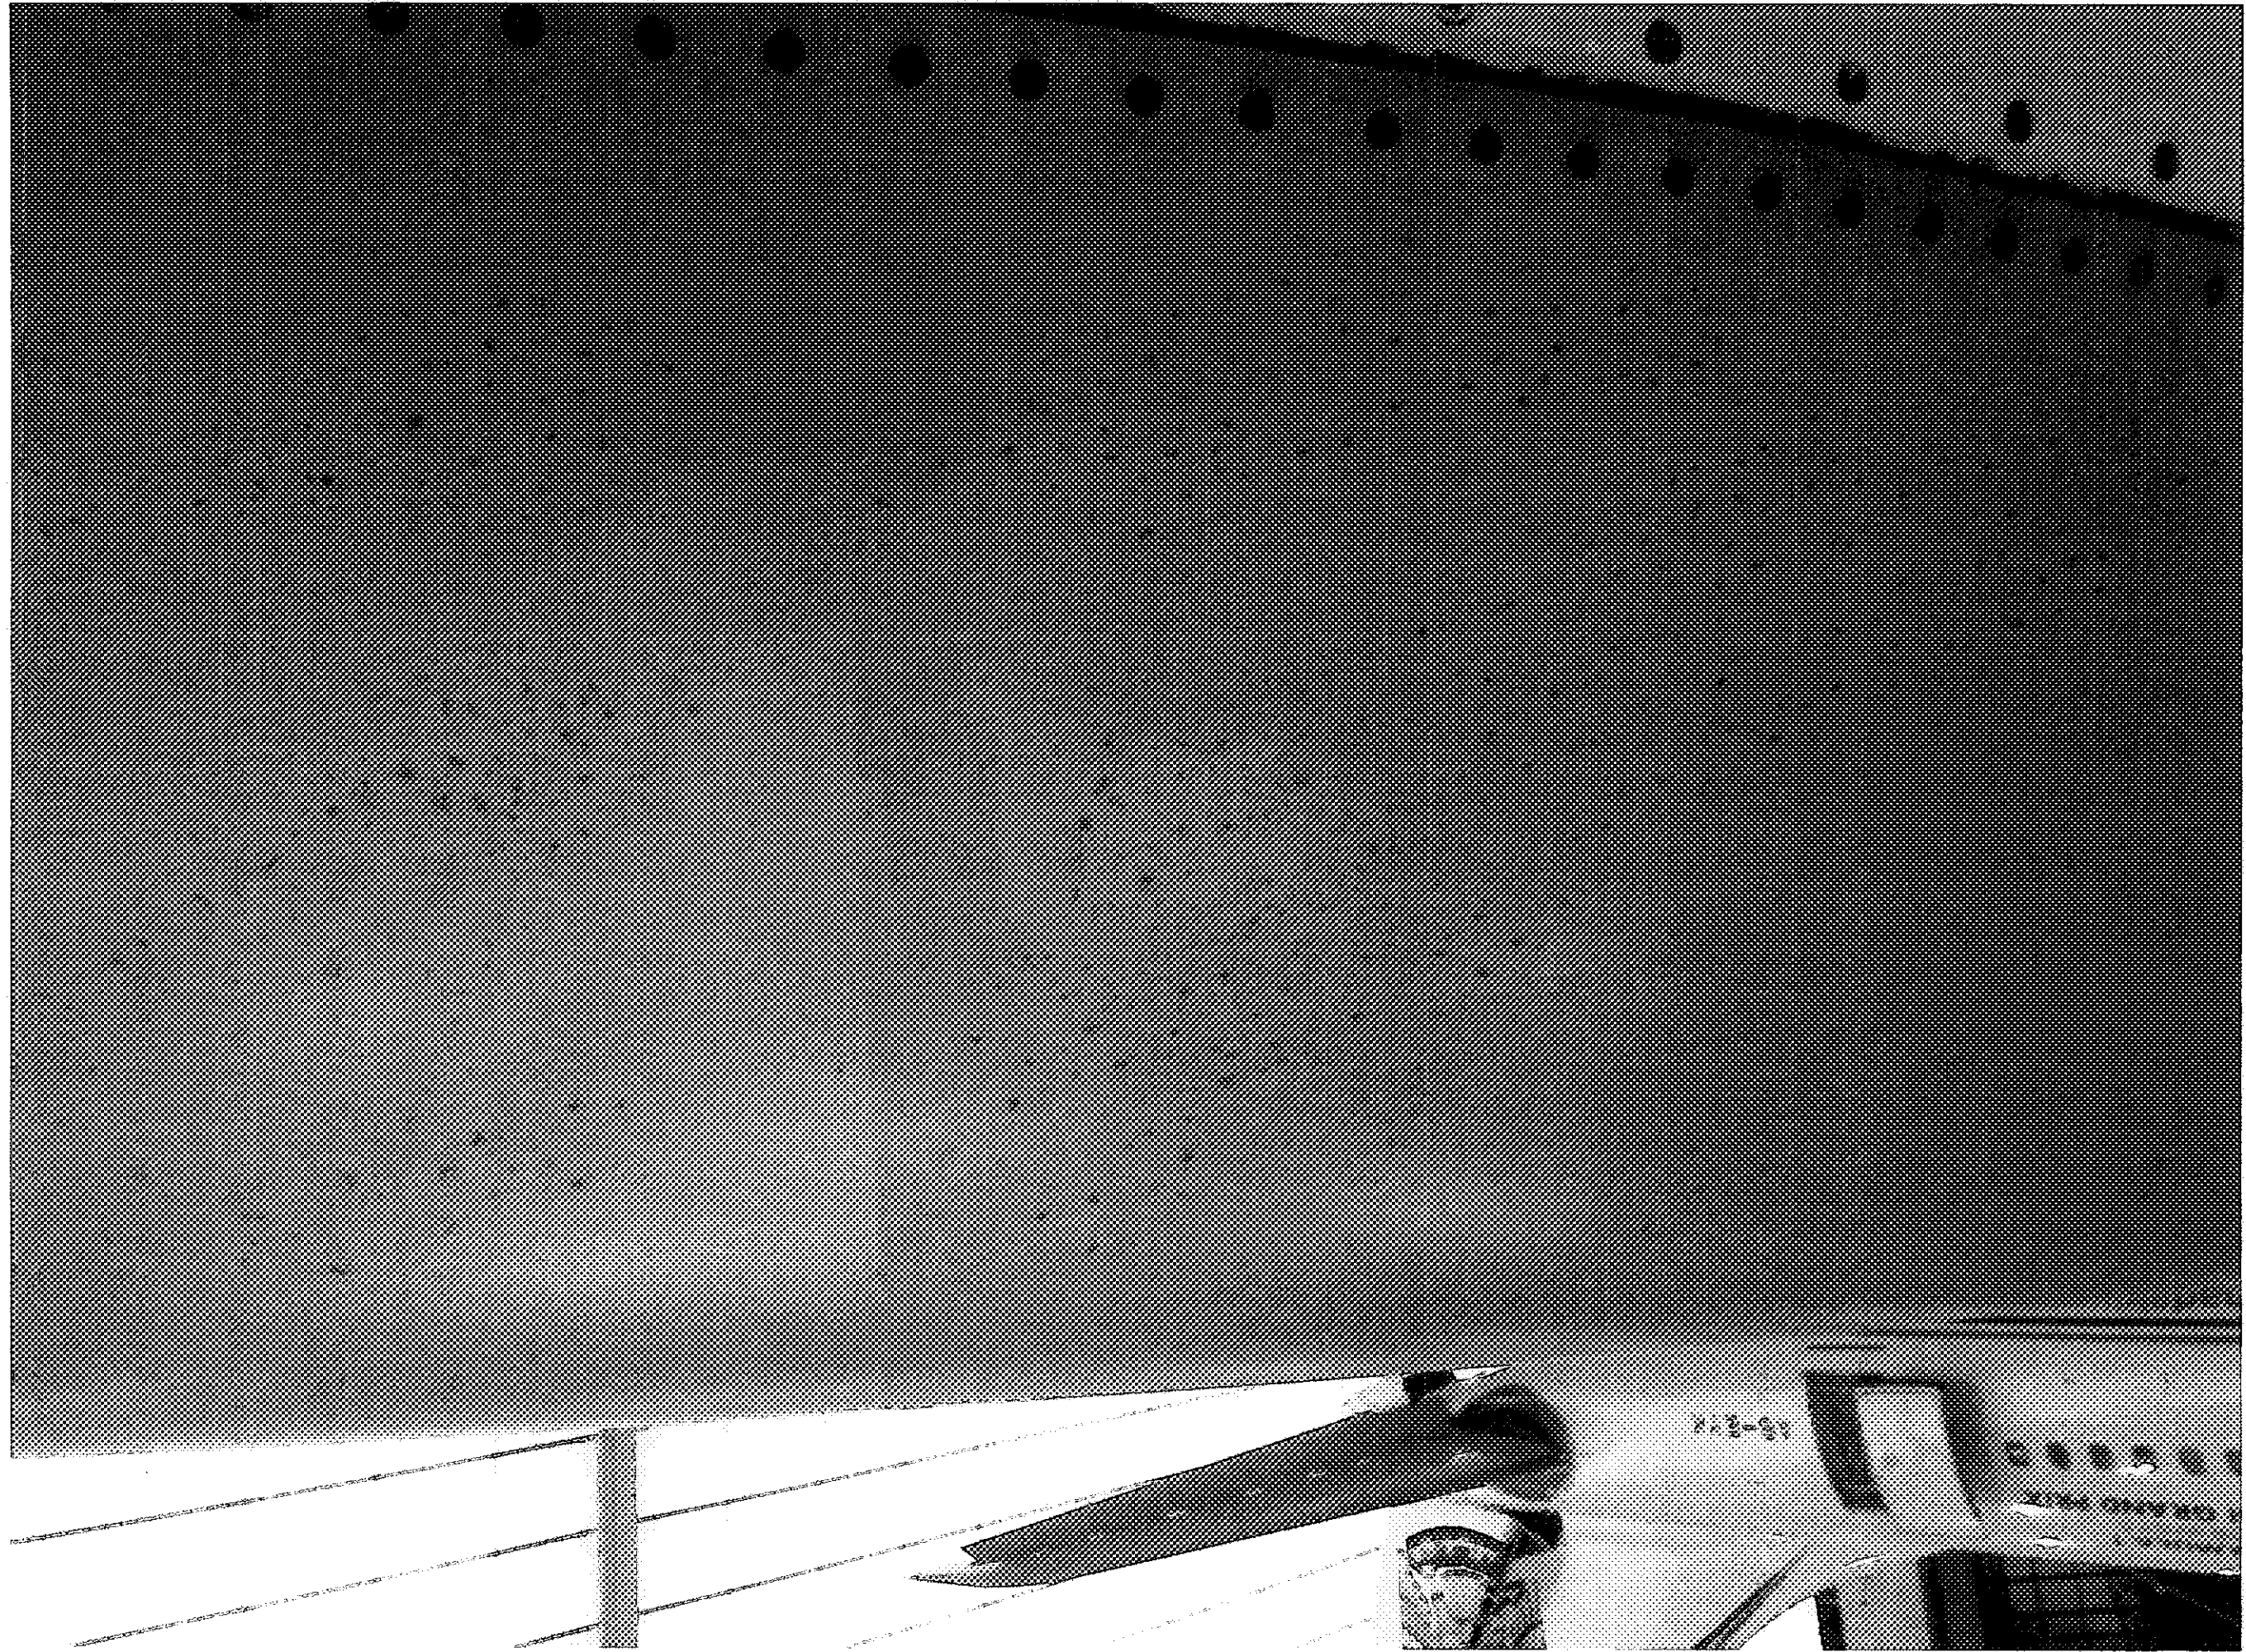
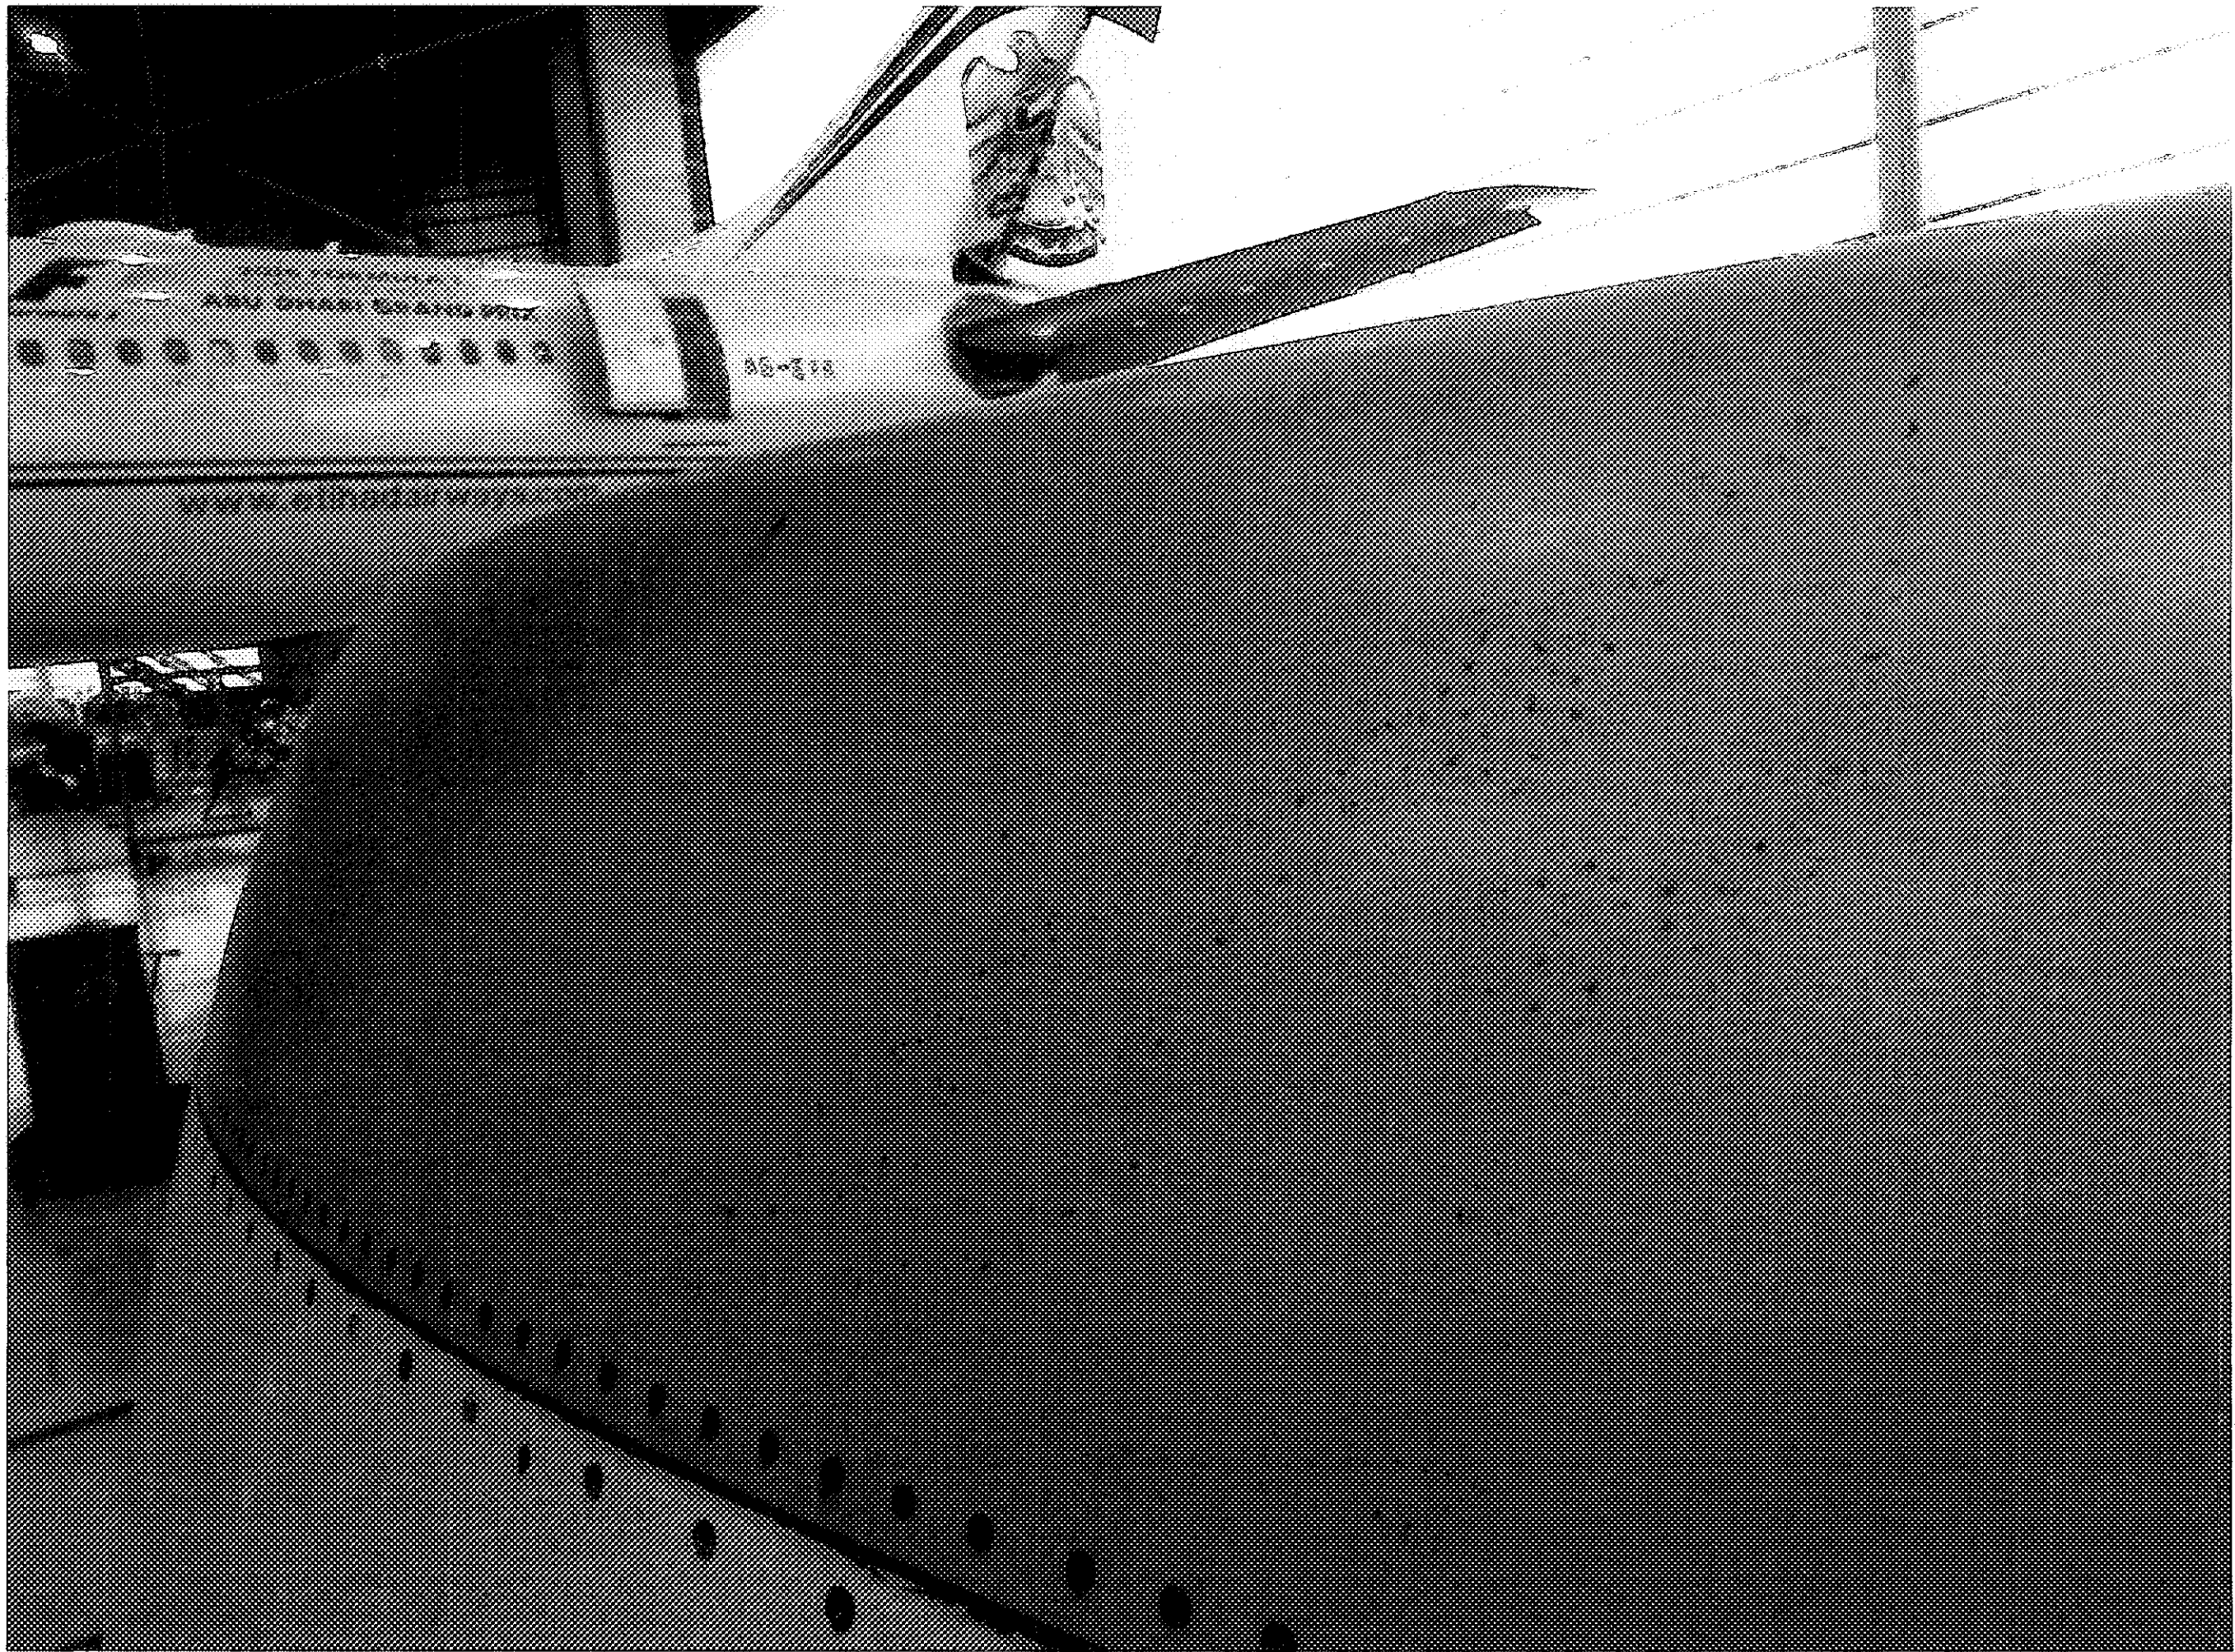
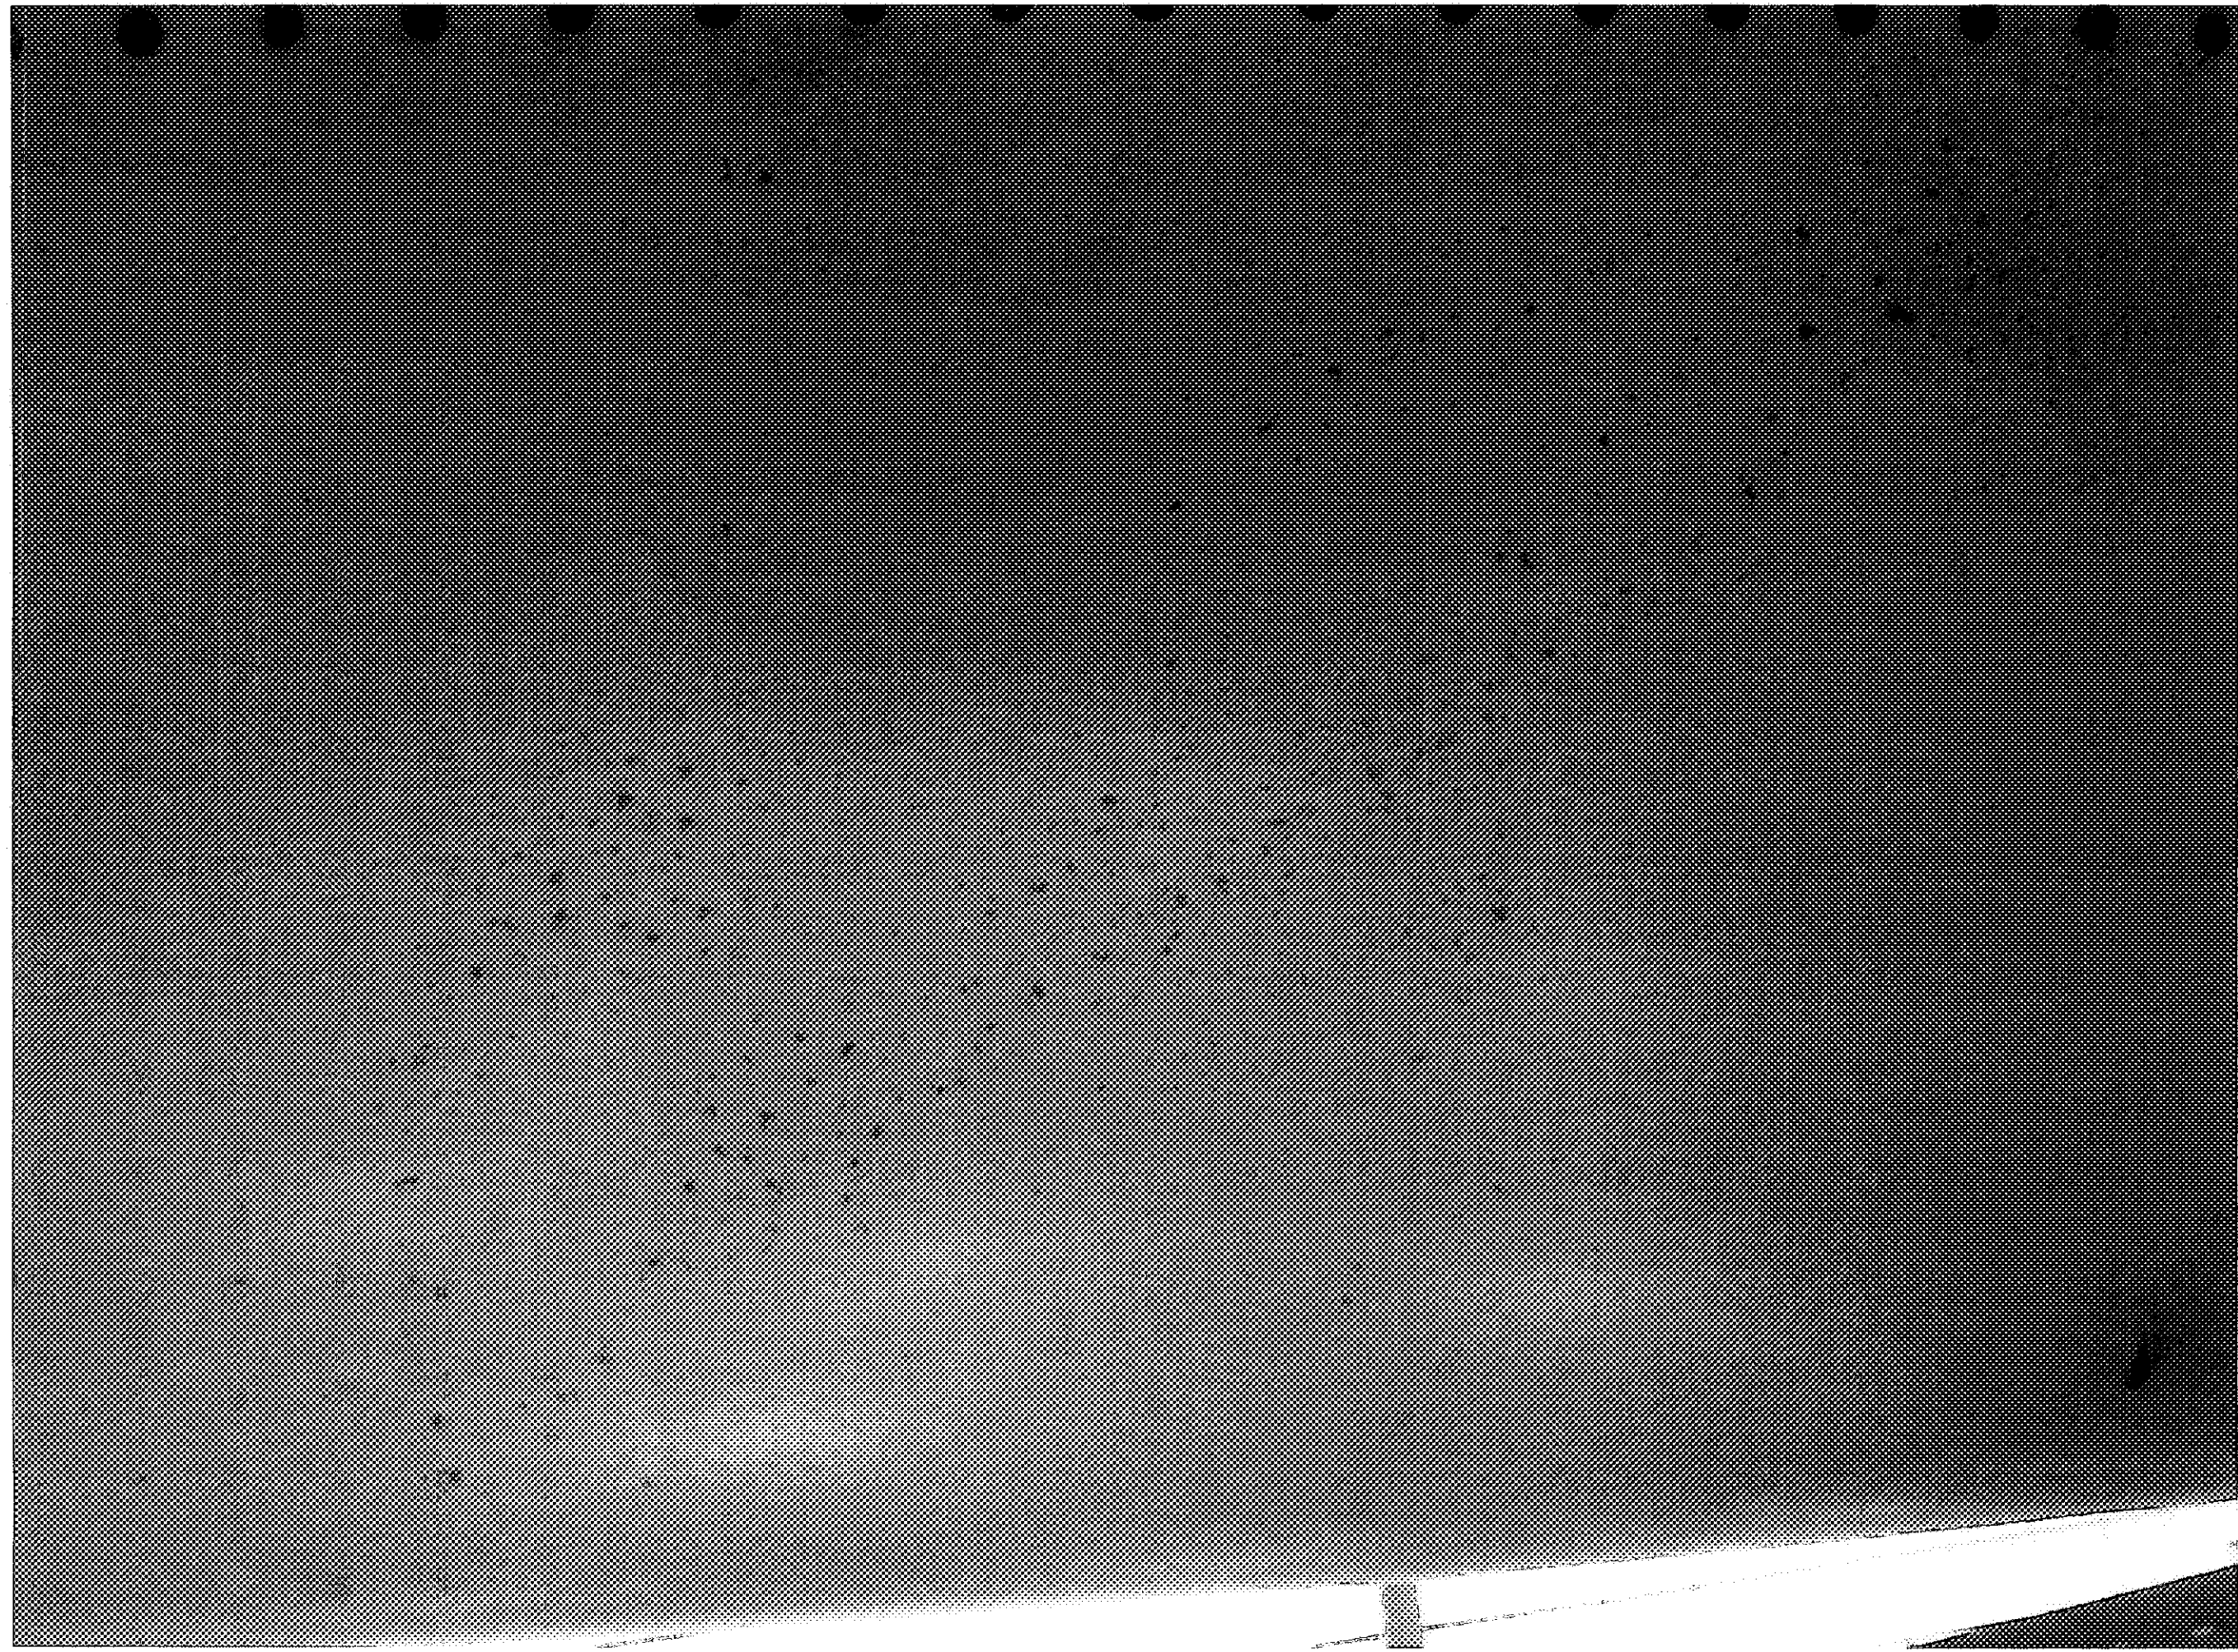
**TR 21371H - A6-LRE - LH ENG - INLET COWL LIP SKIN - CORROSION**

During the current maintenance visit; surface/pitting corrosion was found on LH ENG Inlet Cowl Lip Skin Upper Half, the corrosion is extending all over the lip segment, refer to the attached file for more details.

After reviewing the related SRM reference 54-13-01-1A-1; we couldn't find any limitation/repair for the corrosion finding.

EYE is intending to remove the corrosion using the sanding method, followed by dye penetrant inspection.

1. Remove the damage per the Ref /B/ SRM. Maintain a surface finish of 125 microinches Ra or smoother.
2. Accomplish an HFEC surface inspection per 777 NDT Manual Part 6, 51-00-01 or Fluorescent Penetrant Inspection per SOPM 20-20-02 Type-1, Method-C, Level-3 or higher on the reworked areas to ensure all damage has been removed and there are no cracks.
3. The allowable damage limits for the inlet cowl lip skin provided in Ref /C/ apply. See Figure 103, Details A, B, C, and D.
4. Provided the allowable damage limits in Ref /C/ are not exceeded, apply

Boeing apologizes for the oversight. These are the applicable Ref /B/ 777-200 SRM 51-10-02 and Ref /C/ 777-200 SRM 54-13-01 Allowable Damage 1 references.
