MINI PACK

B777 Stab Trim Actuator Assy

251W4110-18

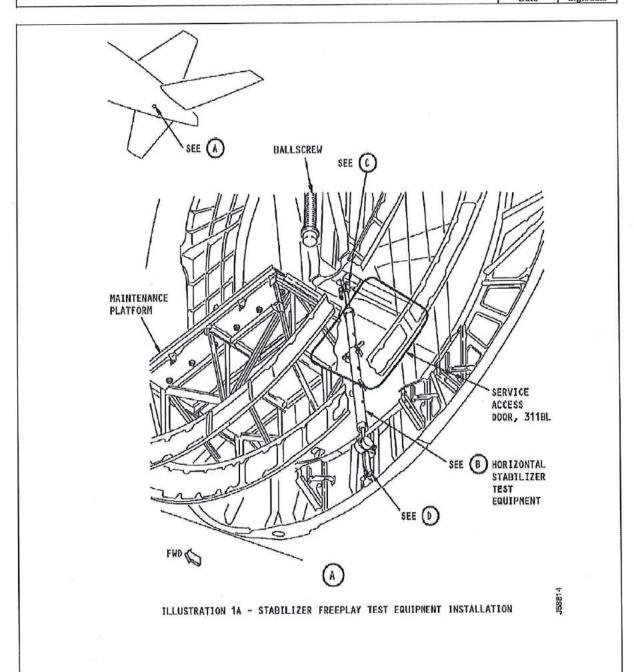
Appendix A: HORIZONTAL STABILIZER TRIM ACTUATOR - BALLSCREW-TO-BALLNUT FREEPLAY INSPECTION (SHEET 3 OF 10)

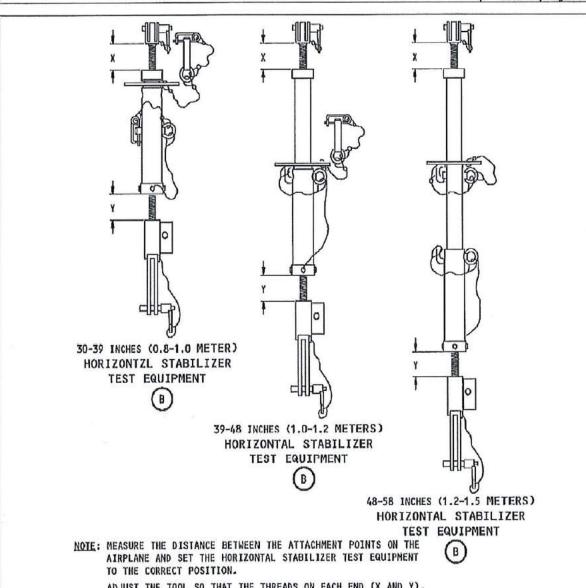
ILLUSTRATION 1B - STABILIZER FREEPLAY TEST EQUIPMENT INSTALLATION

ADJUST THE TOOL SO THAT THE THREADS ON EACH END (X AND Y), ARE APPROXIMATELY THE SAME LENGTH.

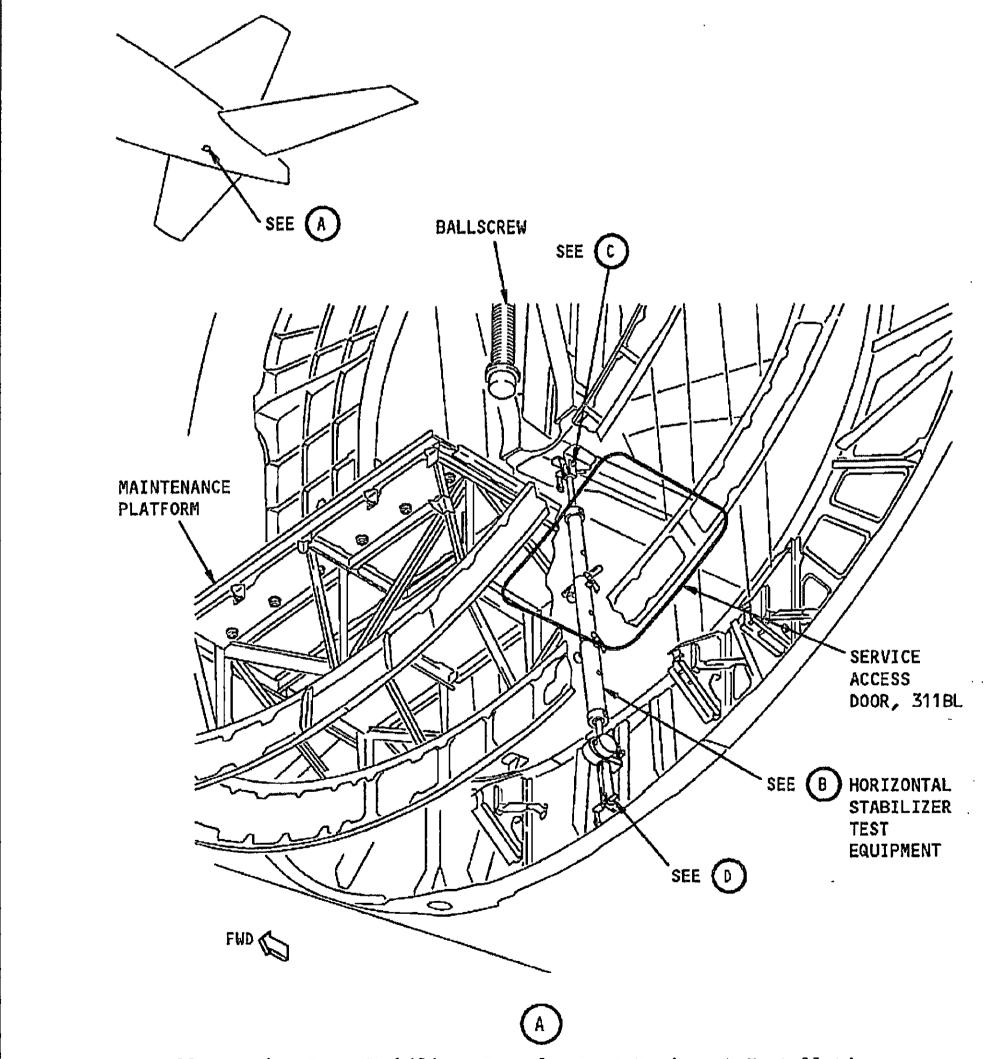
Illustration la - Stabilizer Freeplay Test Equipment Installation

Appendix A: HORIZONTAL STABILIZER TRIM ACTUATOR - BALLSCREW-TO-BALLNUT FREEPLAY INSPECTION (SHEET 2 OF 8)

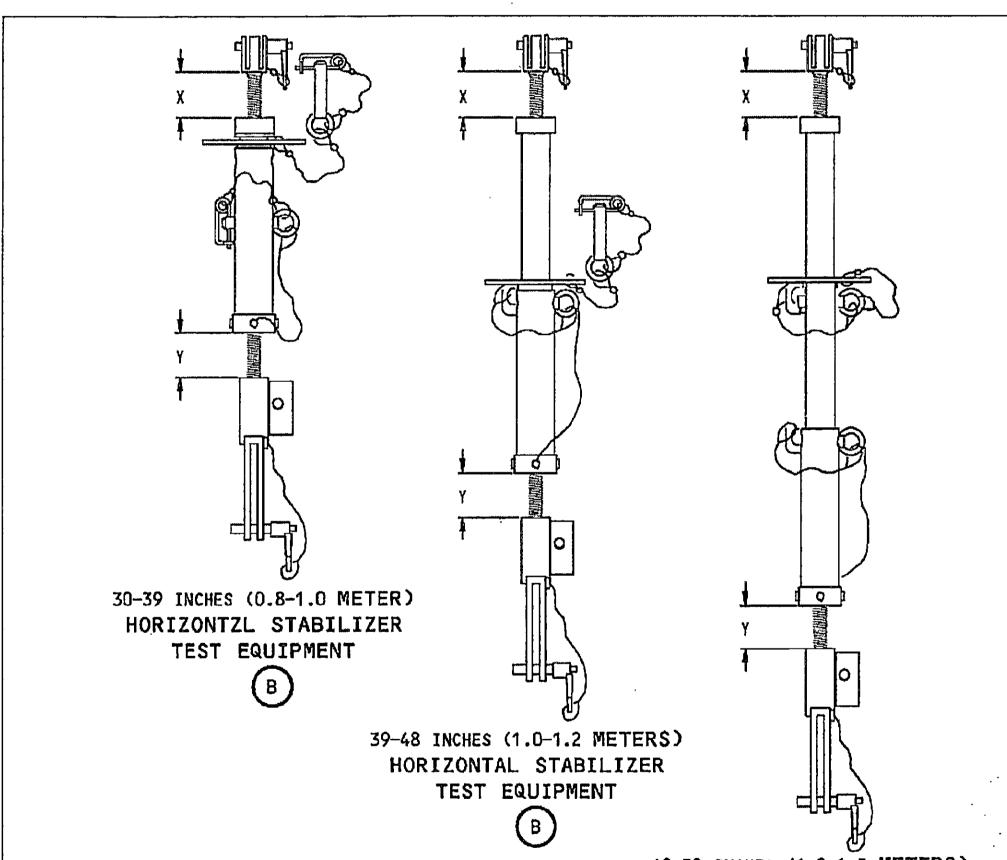
48-58 INCHES (1.2-1.5 METERS)
HORIZONTAL STABILIZER
TEST EQUIPMENT

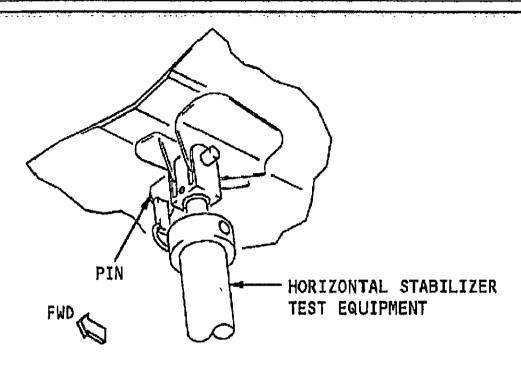
UPPER ATTACHMENT

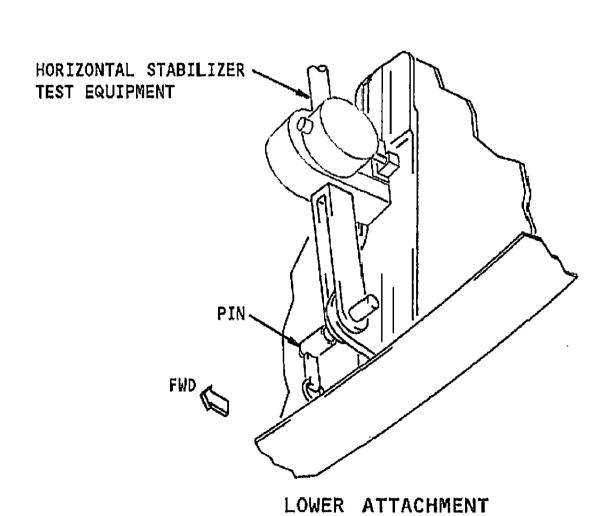
Illustration 1c - Stabilizer Freeplay Test Equipment Installation

Appendix A: HORIZONTAL STABILIZER TRIM ACTUATOR - BALLSCREW-TO-BALLNUT FREEPLAY INSPECTION (SHEET 4 OF 8)

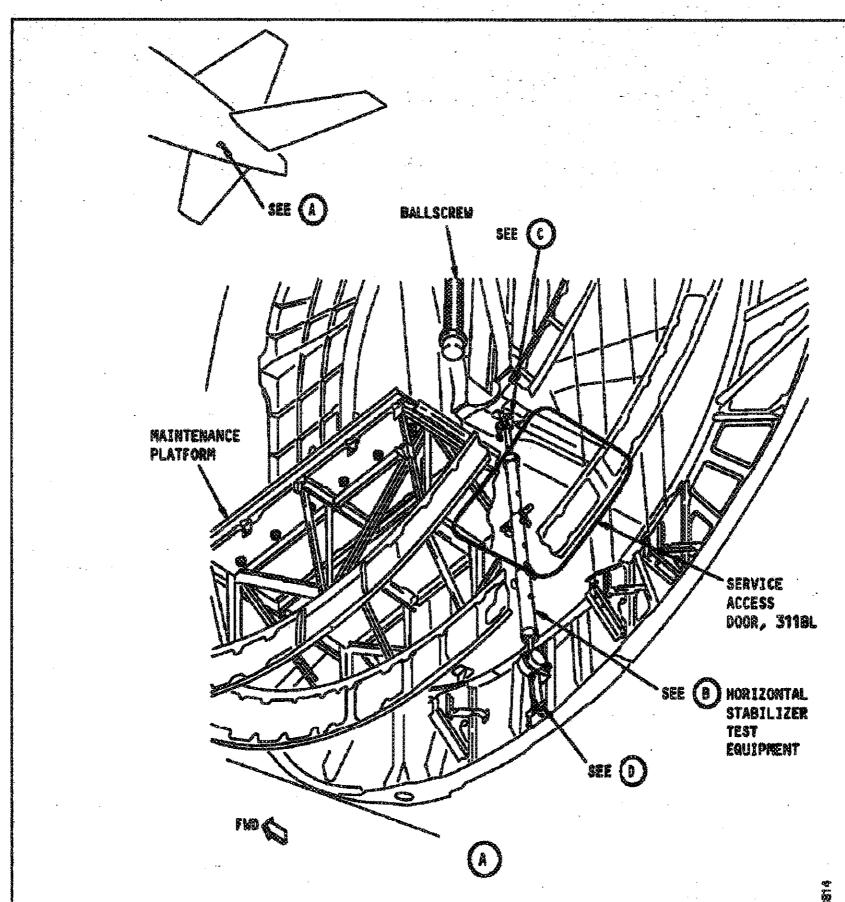
ILLUSTRATION 1A - STABILIZER FREEPLAY TEST EQUIPMENT INSTALLATION

Appendix A: HORIZONTAL STABILIZER TRIM ACTUATOR - BALLSCREW-TO-BALLNUT FREEPLAY INSPECTION (SHEET 3 OF 10)

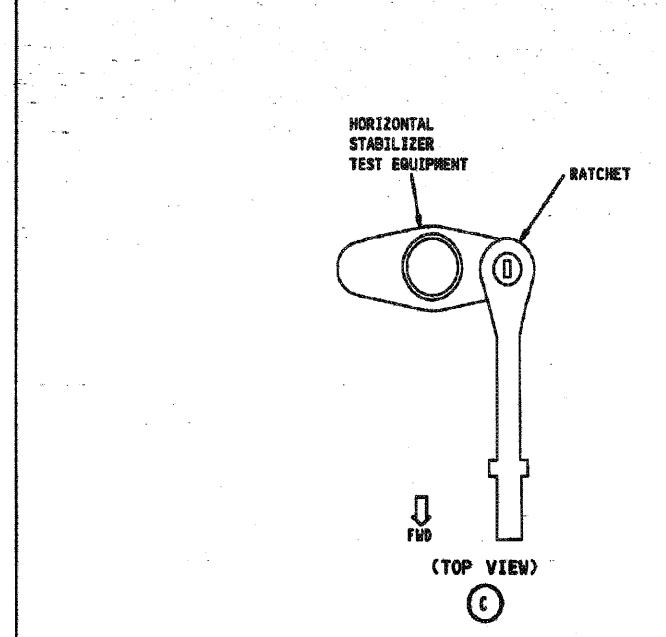
ILLUSTRATION 2C - BALLSCREW TO BALLNUT FREEPLAY INSTALLATION

Appendix A: HORIZONTAL STABILIZER TRIM ACTUATOR - BALLSCREW-TO-BALLNUT FREEPLAY INSPECTION (SHEET 8 OF 10)

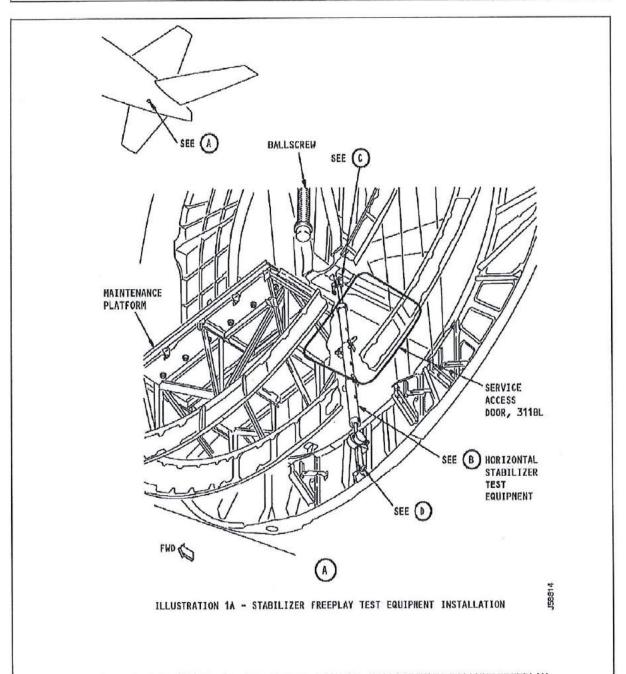
Appendix A: HORIZONTAL STABILIZER TRIM ACTUATOR - BALLSCREW-TO-BALLNUT FREEPLAY INSPECTION (SHEET 3 OF 10)

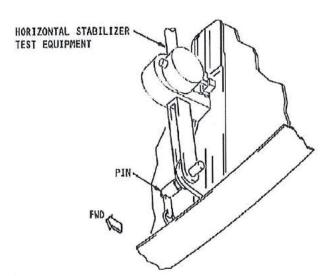
LOWER ATTACHMENT

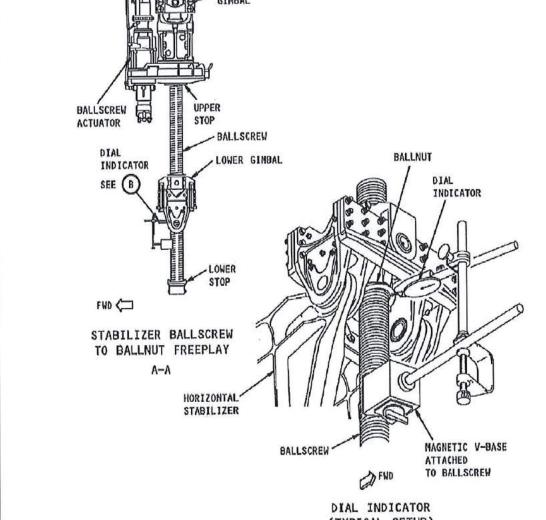
ILLUSTRATION 2B - BALLSCREW TO BALLNUT FREEPLAY INSTALLATION

DIAL INDICATOR (TYPICAL SETUP)
